## Technical Service Bulletin (TSB)

### Flash: Motor Control Processor A (MCP A) Updates 11A1

| REFERENCE: | TSB: 08-010-25 REV. C<br>GROUP: 08 - Electrical | Date: | April 29, 2025 | REVISION: | 08-010-25 REV. B |
| VEHICLES AFFECTED: | 2024 (KM) Jeep Wagoneer S<br>This bulletin applies to vehicles equipped with 400V G2500 FR/RR Elec Drive Motors (Sales Code ELD). | | | MARKET APPLICABILITY:<br><div><input type="checkbox"/> NA<input type="checkbox"/> MEA</div> <div><input type="checkbox"/> **SA<input type="checkbox"/> IAP</div> <div><input type="checkbox"/> EE<input type="checkbox"/> CH**</div> | |

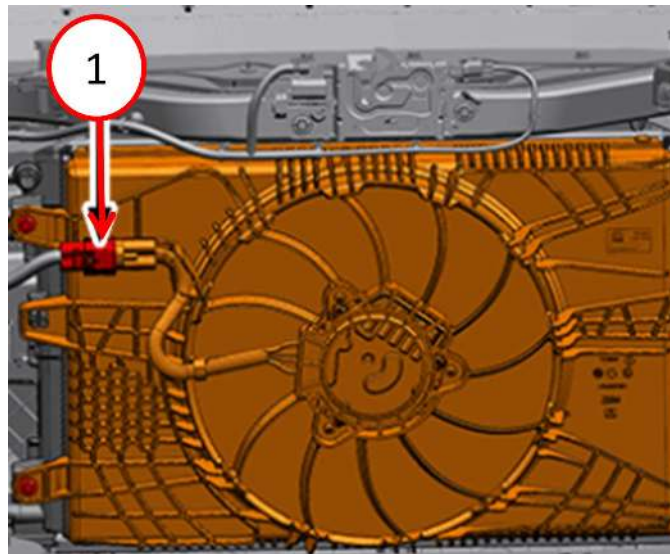
**Fig. 1**  
Cooling Fan Assembly

1 - Wire Harness To Disconnect/Connect

4. Disconnect the cooling fan wire harness connector [Fig. 1](#).\*\*

22. \*\*Connect the cooling fan wire harness connector [Fig. 1](#).
