**RSU With Additional Sleep Cycles for HV Battery Integrity Check  
- Flash: Battery Pack Control Module (BPCM) Updates 11A1**

| REFERENCE: | TSB: 08-076-25 REV. A<br>GROUP: 08 - Electrical | Date: | April 25, 2025 | REVISION: | 08-076-25 |
| VEHICLES AFFECTED: | 2024 (KM) Jeep Wagoneer S<br>This bulletin applies to vehicles equipped with 400V G2500 FR/RR Elec Drive Motors (Sales Code ELD). | | | MARKET APPLICABILITY:<br><div><input type="checkbox"/> NA<input type="checkbox"/> **IAP**<br/><input type="checkbox"/> **SA**<input type="checkbox"/> **CH**<br/><input type="checkbox"/> **EE**<br/><input type="checkbox"/> **MEA**<br/>**</div> | |

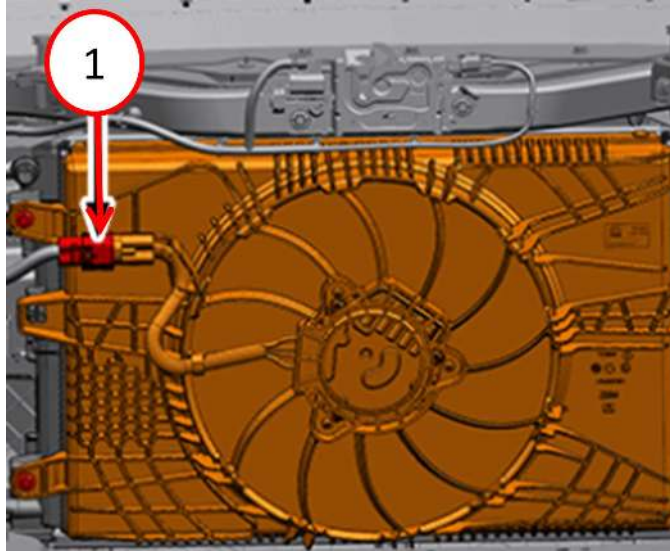
**Fig. 1**  
Cooling Fan Assembly

1 - Wire Harness To Disconnect/Connect

**NOTE: The cooling fan must be disconnected to prevent it from powering on, which may interrupt/abort the flash process.**
4. Disconnect the cooling fan wire harness connector [Fig. 1](#).

26. Connect the cooling fan wire harness connector [Fig. 1](#).
