**RSU With Additional Sleep Cycles for HV Battery Integrity Check  
- Flash: Battery Pack Control Module (BPCM) Updates 11A1**

| REFERENCE: | TSB: 08-076-25 REV. B<br>GROUP: 08 - Electrical | Date: | April 28, 2025 | REVISION: | 08-076-25 REV. A |
| VEHICLES AFFECTED: | 2024 (KM) Jeep Wagoneer S<br>This bulletin applies to vehicles equipped with 400V G2500 FR/RR Elec Drive Motors (Sales Code ELD). | | | MARKET APPLICABILITY:<br><div><input type="checkbox"/> NA<input type="checkbox"/> MEA<br/><input type="checkbox"/> SA<input type="checkbox"/> IAP<br/><input type="checkbox"/> EE<input type="checkbox"/> CH</div> | |

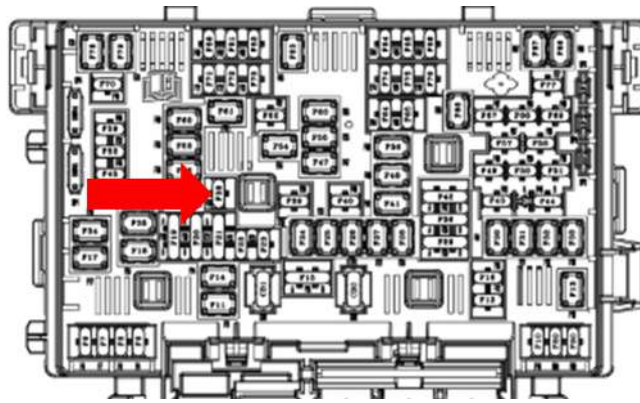
**Fig. 3**  
#38 AGSM Fuse Location

**Failure to remove the #38 AGSM fuse will result in damage to the shifter.**

6. Remove the PDC cover, locate and remove the #38 AGSM fuse [Fig. 3](#).

24. Install the #38 AGSM fuse [Fig. 3](#) and the PDC cover [Fig. 2](#).
