| Technical Journal Title<br>CEL with DTC ECM P001100, P001200, P001400, P001500 | | Ref. No.<br>TJ 37148.4.0 | |

## Technical Journal 37148.4.0

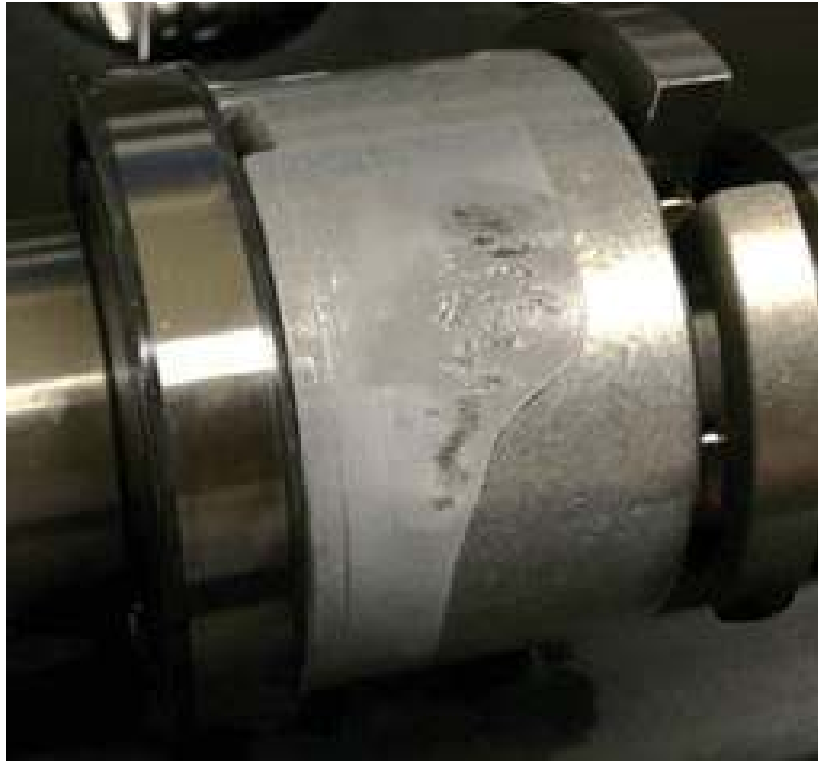
\*Wear on the outside of the camshaft is not a reason to replace the part. Compare with the attached file TJ\_36920\_1.PNG.
