## Technical Journal

| Technical Journal Title<br>CEL with DTC ECM P001100, P001200, P001400, P001500 | | Ref. No.<br>TJ 37148.5.0 | |

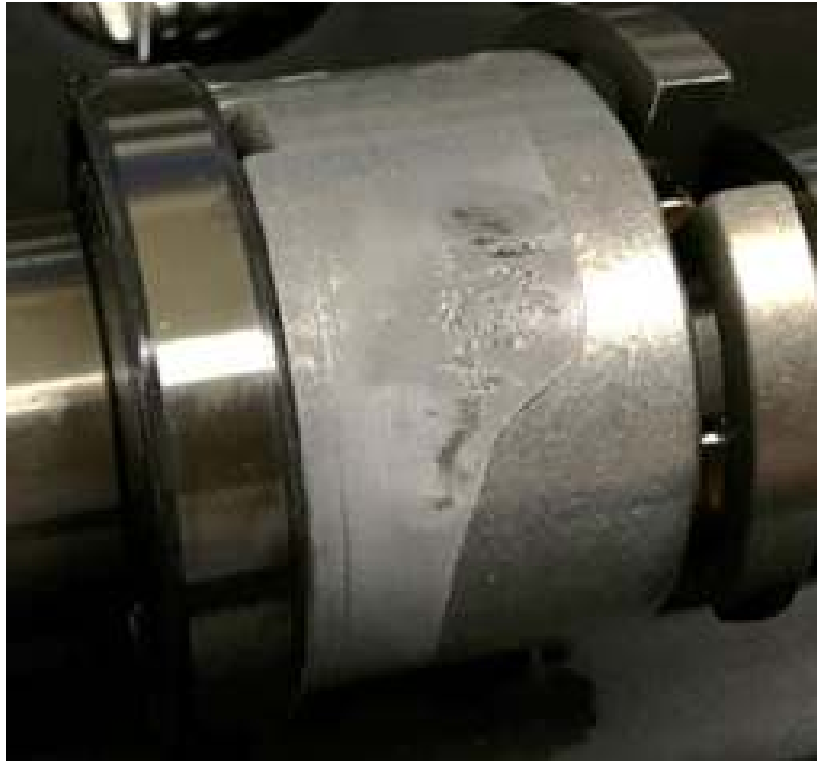
Wear on the outside of the camshaft is not a reason to replace the part. Compare with the attached file TJ\_36920\_1.PNG.
