| REFERENCE: | TSB: 08-014-25 REV. C<br>GROUP: 08 - Electrical | Date: | July 2, 2025 | REVISION: | 08-014-25 REV. B |
| VEHICLES AFFECTED: | 2024 (KM) Jeep Wagoneer S<br>This bulletin applies to vehicles equipped with 400V G2500 FR/RR Elec Drive Motors (Sales Code ELD). | | | MARKET APPLICABILITY:<br><div><input checked="" type="checkbox"/> NA<input checked="" type="checkbox"/> MEA<br/><input checked="" type="checkbox"/> SA<input checked="" type="checkbox"/> IAP<br/><input checked="" type="checkbox"/> EE<input checked="" type="checkbox"/> CH</div><br>NOTE: **This bulletin applies to North and South America, Enlarged Europe, Middle East & Africa, India & Asia Pacific and China markets.** | |
| CAUSE: | EVCU software update | | | | |

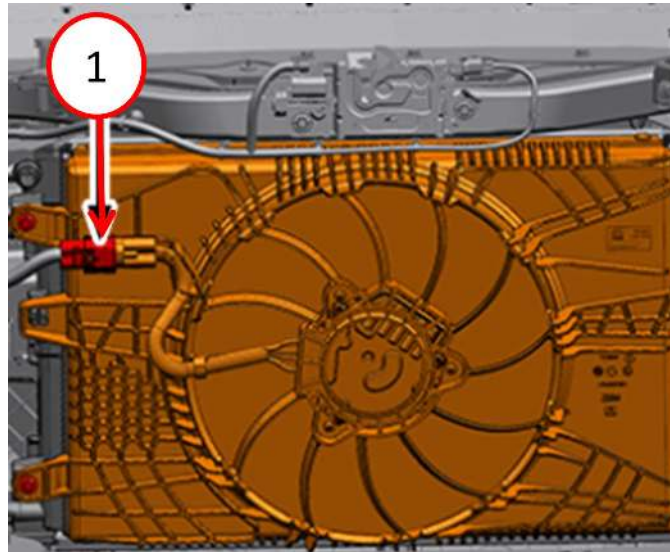
**Fig. 1**  
Cooling Fan Assembly

**NOTE:** The cooling fan must be disconnected to prevent it from powering on, which may interrupt/ abort the flash process.

4. Disconnect the cooling fan wire harness connector [Fig. 1](#).

22. Connect the cooling fan wire harness connector [Fig. 1](#).
