Model Series 463 AMG: Active Distance Assist and  
Active Brake Assist IC Message and DTC U0416FE

| Topic number | LI54.71-P-078112 |
| Function group | 54.71 - Camera and radar-assisted assistance systems |

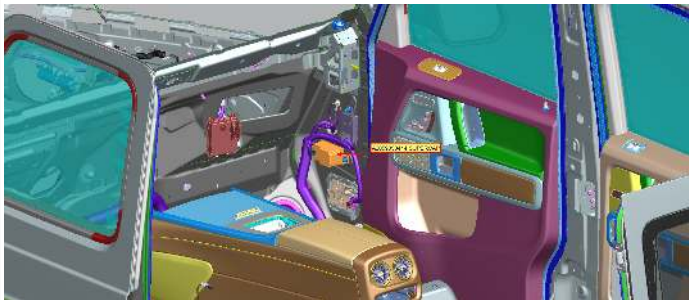
| File | Description |
|---|---|
| <a href="#">Steuergerät+SUPERCAP+Lage+im+Fzg+weit..png</a><br> | Picture 1 - Connection from Supercap to Drive Unit |

Missing wire between Drive Unit (N145) and Supercap (C8).

- Using a red/white cable with cross-section 0.35 mm² and overall length of approximately 2m.
- Connect Drive Unit (N145) plug A pin 18 to the 3-pin plug of the Supercap (C8) terminal 15 pin 2. Reference the new wire routing location as shown by the red line in "Picture 1 - Connection from Supercap to Drive Unit".
- The new wire should be added to the existing wiring harness as shown by the red line "Picture 1 - Connection from Supercap to Drive Unit".
- Z-Splice is the preferred method using A 000 982 91 10.
- Crimp Contact Pin (MLK) for the Drive Unit (N145) is A0485450328.
