**Technical Service Bulletin (TSB)**  
**Flash: Powertrain Control Module (PCM) Updates**

| REFERENCE: | TSB: 18-011-25 REV. A<br>GROUP: 18 - Vehicle Performance | Date: | July 25, 2025 | REVISION: | 18-011-25 |
| VEHICLES AFFECTED: | 2024 (JL) Jeep Wrangler<br>This bulletin applies to vehicles equipped with the 2.0L I4 DOHC DI Turbo Engine W/ESS (Sales Code EC1). | | | MARKET APPLICABILITY:<br><div><input checked="" type="checkbox"/> NA<input checked="" type="checkbox"/> **IAP**<br/><input checked="" type="checkbox"/> **SA**<input type="checkbox"/> **CH**<br/><input type="checkbox"/> EE<br/><input checked="" type="checkbox"/> **MEA**<br/>**</div><br><div>NOTE: **This bulletin applies to the North and South America, India &amp; Asia Pacific, Middle East and Africa and China markets.**</div> | |

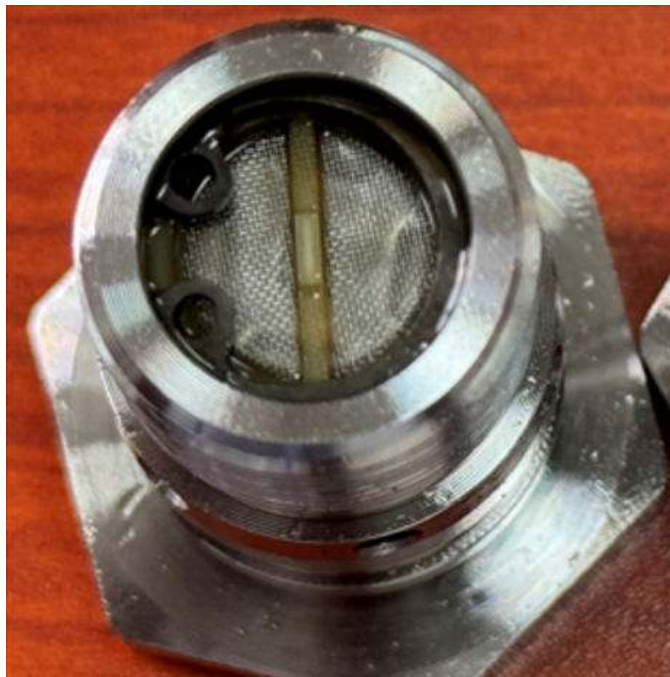
**Fig. 1**  
OCV Filter OK

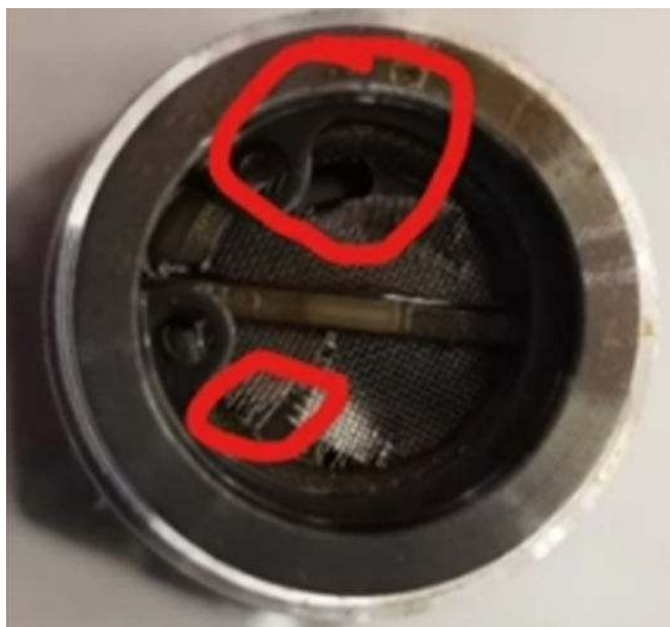
**Fig. 2**  
OCV Filter Torn

5. Are the OCV filter screen(s) torn?

- YES>>> Replace the OCV(s) and change the engine oil and filter. Refer to the detailed service procedures listed in DealerCONNECT>Service Library>Service Info>under: 09 - Engine, 2.0L / Lubrication / Standard Procedure Engine oil and filter change. Use LOPs (09-05-37-91) and (26-99-00-10). Proceed to [Step 11](#).
- NO>>> Proceed to [Step 6](#).

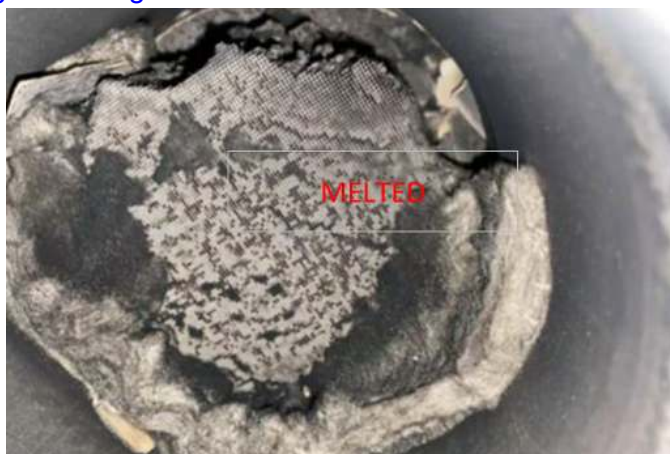
10. Remove the Upstream Oxygen Sensor and using a borescope, is the catalytic converter internally melted/ cracked or brain pattern [Fig. 3](#) and [Fig. 4](#) ?

**Fig. 3**  
Melted Catalyst

- YES>>> Replace the catalytic converter. Refer to the detailed service procedures listed in DealerCONNECT>Service Library>Service Info>under: 11 - Exhaust System / Converter, Catalytic / Removal and Installation. Use LOP (11-50-01-91). Proceed to [Step 11](#).
- NO>>> Use Inspect LOP (11-50-01-90). Proceed to [Step 11](#).
