DCDC Sensor fault codes due to faulty wake-up behavior

| Topic number | LI54.10-P-079533 |
| Function group | 54.10 - Battery, power supply, voltage converter |
| Validity | The DC/DC converter type that is installed in model series 243 and 465 can be affected. |

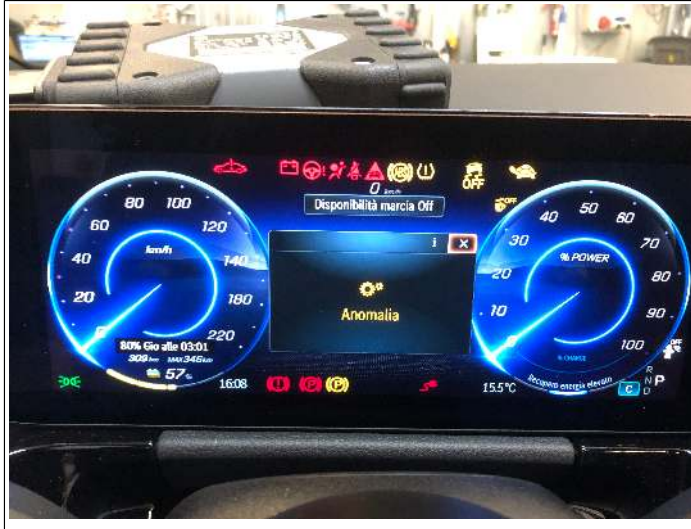
243: As a consequence, on vehicles with BMS30EB02, the DTC for the auxiliary assembly fuse P0E2F00 can be set in this.

This triggers the yellow HV drive system warning message.

| Attachments | |
|---|---|
| DCDC223 243 Sensor issue gelbe Hybrid Antriebssystem WEM.jpg | 243 yellow HV drive system warning message - can only be deleted via XENTRY |

Since the BMS on 243 uses the HV voltage value to check the auxiliary assembly fuse, the auxiliary assembly DTC can (with BMS30EB02) be stored as a consequence and the second (yellow) HV drive system warning message can be displayed in the IC.

Clear the fault memory, since the DTC for the auxiliary assembly fuse and the yellow hybrid drive system warning message can only be reset in this way.
