**Technical Service Bulletin (TSB)**  
**Flash: Electronic Vehicle Control Unit (EVCU) Updates 11A2**

| REFERENCE: | TSB: 08-204-25 REV. C<br>GROUP: 08 - Electrical | Date: | August 30, 2025 | REVISION: | 08-204-25 REV. B |
| VEHICLES AFFECTED: | 2024 (LB) Dodge Charger<br>This bulletin applies to vehicles equipped with 400V G2500 FR/RR Elec Drive Motors (Sales Code ELD). | | | <b>MARKET APPLICABILITY:</b><br><div><input checked="" type="checkbox"/> NA<input checked="" type="checkbox"/> MEA<br/><input checked="" type="checkbox"/> SA<input checked="" type="checkbox"/> IAP<br/><input checked="" type="checkbox"/> EE<input checked="" type="checkbox"/> CH</div> <b>NOTE:</b> This bulletin applies to North and South America, Enlarged Europe, Middle East & Africa, India & Asia Pacific and China markets. | |

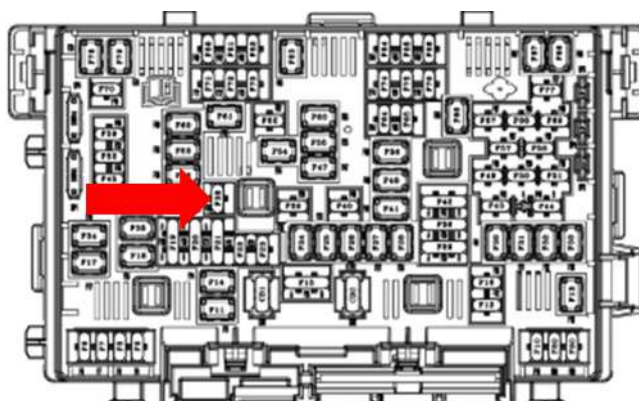
**Fig. 3**  
#38 AGSM Fuse Location

**Failure to remove the #38 AGSM fuse will result in damage to the shifter.**

6. Remove the PDC cover, locate and remove the #38 AGSM fuse [Fig. 3](#).

16. Install the #38 AGSM fuse [Fig. 3](#) and the PDC cover [Fig. 2](#).
17. Position the rear carpet in place.
18. \*\*Connect the cooling fan wire harness connector [Fig. 1](#).
19. Install the front storage bin. Refer to the detailed service procedures available in DealerCONNECT/ServiceLibrary under: Service Info> 23 - Body / Exterior / Bin, Storage / Installation.\*\*
