## Technical Service Bulletin (TSB)

### Flash: Electronic Vehicle Control Unit (EVCU) Updates 11A2

| REFERENCE: | TSB: 08-206-25 REV. C<br>GROUP: 08 - Electrical | Date: | August 30, 2025 | REVISION: | 08-206-25 REV. B |
| VEHICLES AFFECTED: | 2024 (KM) Jeep Wagoneer S<br>This bulletin applies to vehicles equipped with 400V G2500 FR/RR Elec Drive Motors (Sales Code ELD). | | | MARKET APPLICABILITY:<br><div><input checked="" type="checkbox"/> NA<input checked="" type="checkbox"/> MEA<br/><input checked="" type="checkbox"/> SA<input checked="" type="checkbox"/> IAP<br/><input checked="" type="checkbox"/> EE<input checked="" type="checkbox"/> CH</div><br>NOTE: This bulletin applies to North and South America, Enlarged Europe, Middle East & Africa, India & Asia Pacific and China markets. | |

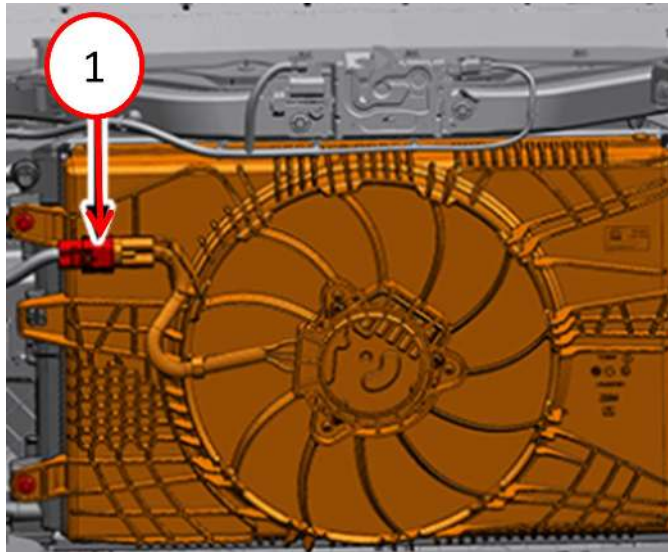
**Fig. 1**  
Cooling Fan Assembly

1 - Wire Harness To Disconnect/Connect

4. Disconnect the cooling fan wire harness connector [Fig. 1](#).\*\*

13. \*\*Connect the cooling fan wire harness connector [Fig. 1](#).
14. Install the front storage bin. Refer to the detailed service procedures available in DealerCONNECT/ServiceLibrary under: Service Info> 23 - Body / Exterior / Bin, Storage / Installation.\*\*
