**Technical Service Bulletin (TSB)**  
**Flash: Electronic Vehicle Control Unit (EVCU) Updates 6A2**

| REFERENCE: | TSB: 08-205-25 REV. C<br>GROUP: 08 - Electrical | Date: | August 30, 2025 | REVISION: | 08-205-25 REV. B |
| VEHICLES AFFECTED: | 2025 (LB) Dodge Charger<br>This bulletin applies to vehicles built on or before April 25, 2025 (MDH 0425XX) equipped with 400V G2500 FR/RR Elec Drive Motors (Sales Code ELD). | | | <b>MARKET APPLICABILITY:</b><br><div><input checked="" type="checkbox"/> NA<input checked="" type="checkbox"/> MEA<br/><input checked="" type="checkbox"/> SA<input checked="" type="checkbox"/> IAP<br/><input checked="" type="checkbox"/> EE<input checked="" type="checkbox"/> CH</div> <b>NOTE:</b> This bulletin applies to North and South America, Enlarged Europe, Middle East & Africa, India & Asia Pacific and China markets. | |

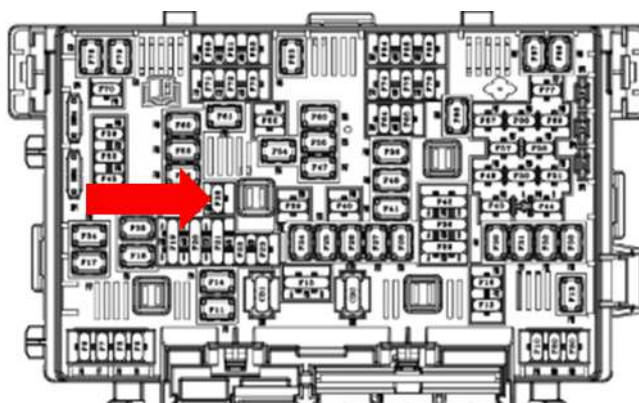
**Fig. 3**  
#38 AGSM Fuse Location

**Failure to remove the #38 AGSM fuse will result in damage to the shifter.**

6. Remove the PDC cover, locate and remove the #38 AGSM fuse [Fig. 3](#).

16. Install the #38 AGSM fuse [Fig. 3](#) and the PDC cover [Fig. 2](#).
17. Position the rear carpet in place.
18. \*\*Connect the cooling fan wire harness connector [Fig. 1](#).
19. Install the front storage bin. Refer to the detailed service procedures available in DealerCONNECT/ServiceLibrary under: Service Info> 23 - Body / Exterior / Bin, Storage / Installation.\*\*
