**Technical Service Bulletin (TSB)**  
**Flash: Electronic Vehicle Control Unit (EVCU) Updates 6A2**

| REFERENCE: | TSB: 08-207-25 REV. D<br>GROUP: 08 - Electrical | Date: | August 30, 2025 | REVISION: | 08-207-25 REV. C |
| VEHICLES AFFECTED: | 2025 (KM) Jeep Wagoneer S<br>This bulletin applies to vehicles built on or before June 20, 2025 (MDH 0620XX) equipped with 400V G2500 FR/RR Elec Drive Motors (Sales Code ELD). | | | <b>MARKET APPLICABILITY:</b><br><div><input checked="" type="checkbox"/> NA<input checked="" type="checkbox"/> MEA<br/><input checked="" type="checkbox"/> SA<input checked="" type="checkbox"/> IAP<br/><input checked="" type="checkbox"/> EE<input checked="" type="checkbox"/> CH</div> <b>NOTE:</b> This bulletin applies to North and South America, Enlarged Europe, Middle East & Africa, India & Asia Pacific and China markets. | |

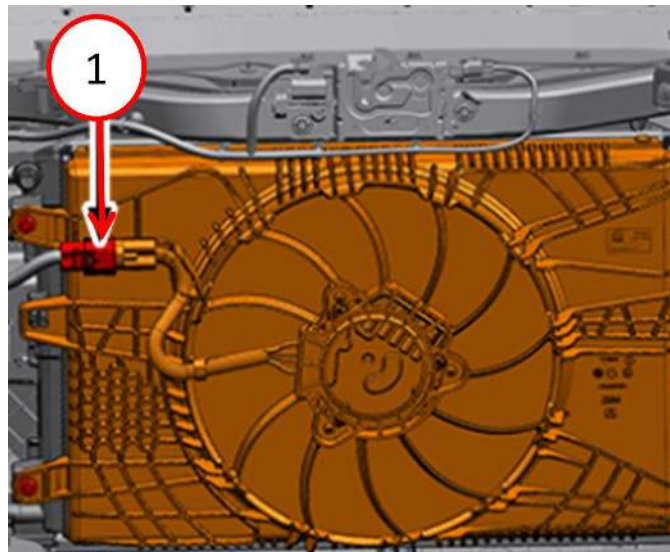
**Fig. 1**  
Cooling Fan Assembly

1 - Wire Harness To Disconnect/Connect

4. Disconnect the cooling fan wire harness connector [Fig. 1](#).\*\*

13. \*\*Connect the cooling fan wire harness connector [Fig. 1](#).
14. Install the front storage bin. Refer to the detailed service procedures available in DealerCONNECT/ServiceLibrary under: Service Info> 23 - Body / Exterior / Bin, Storage / Installation.\*\*
