## Technical Service Bulletin

| <b>Topic</b> | 48 Electric steering column adjustment is not working, DTC B14BF01 is stored in the BCM 1 |
| <b>Transaction No.</b> | 2062288/5 |
| <b>Release date</b> | Aug 2, 2025 |

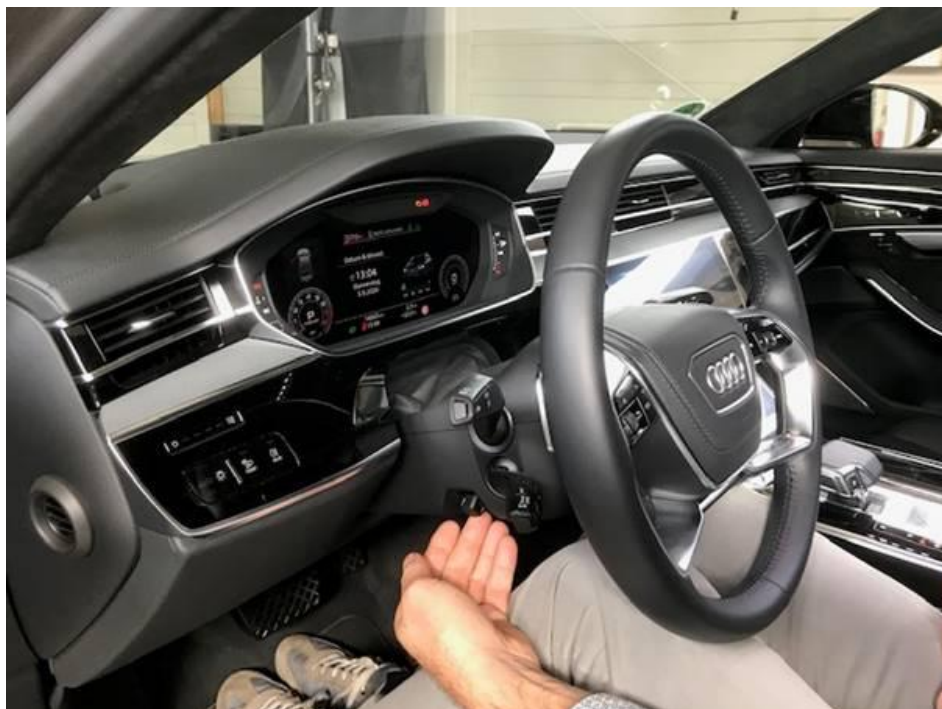
**Figure 1.** 40 kg force pushing steering wheel upward.

- Get into the vehicle and use your knees to push the steering wheel upward (a force of approx. 40 kg or 88 lbs is required), at the same time press the steering column adjustment switch upwards in the vertical adjustment direction (Figure 1).
- This will restore the function of the electric steering column adjustment.

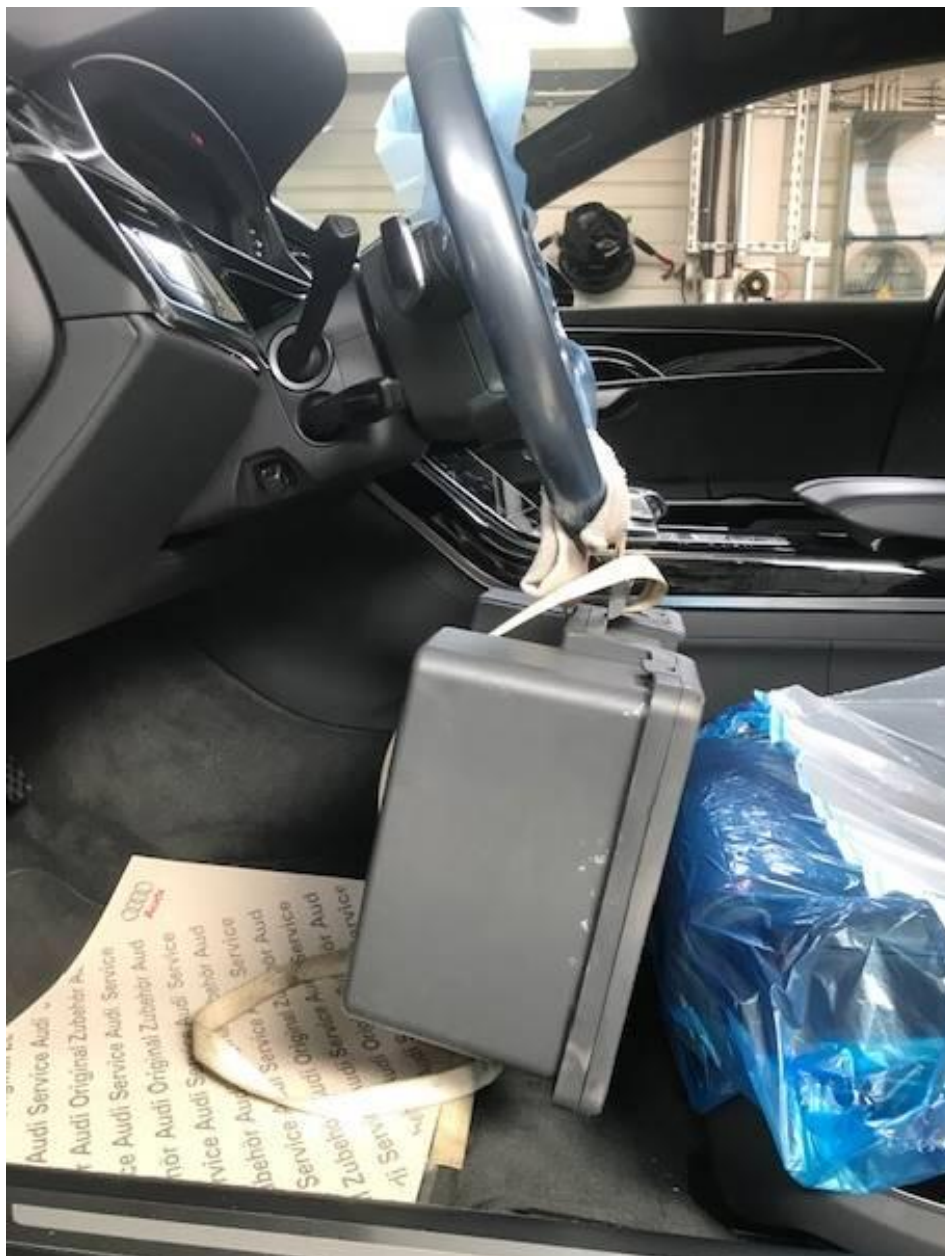
**Figure 2.** Weight necessary for steering adjustment.

6. Attach the tool kit to the steering wheel using a small securing strap (Figure 2). Take care not to damage the steering wheel.

We recommend placing a cleaning cloth underneath, as shown in Figure 2.

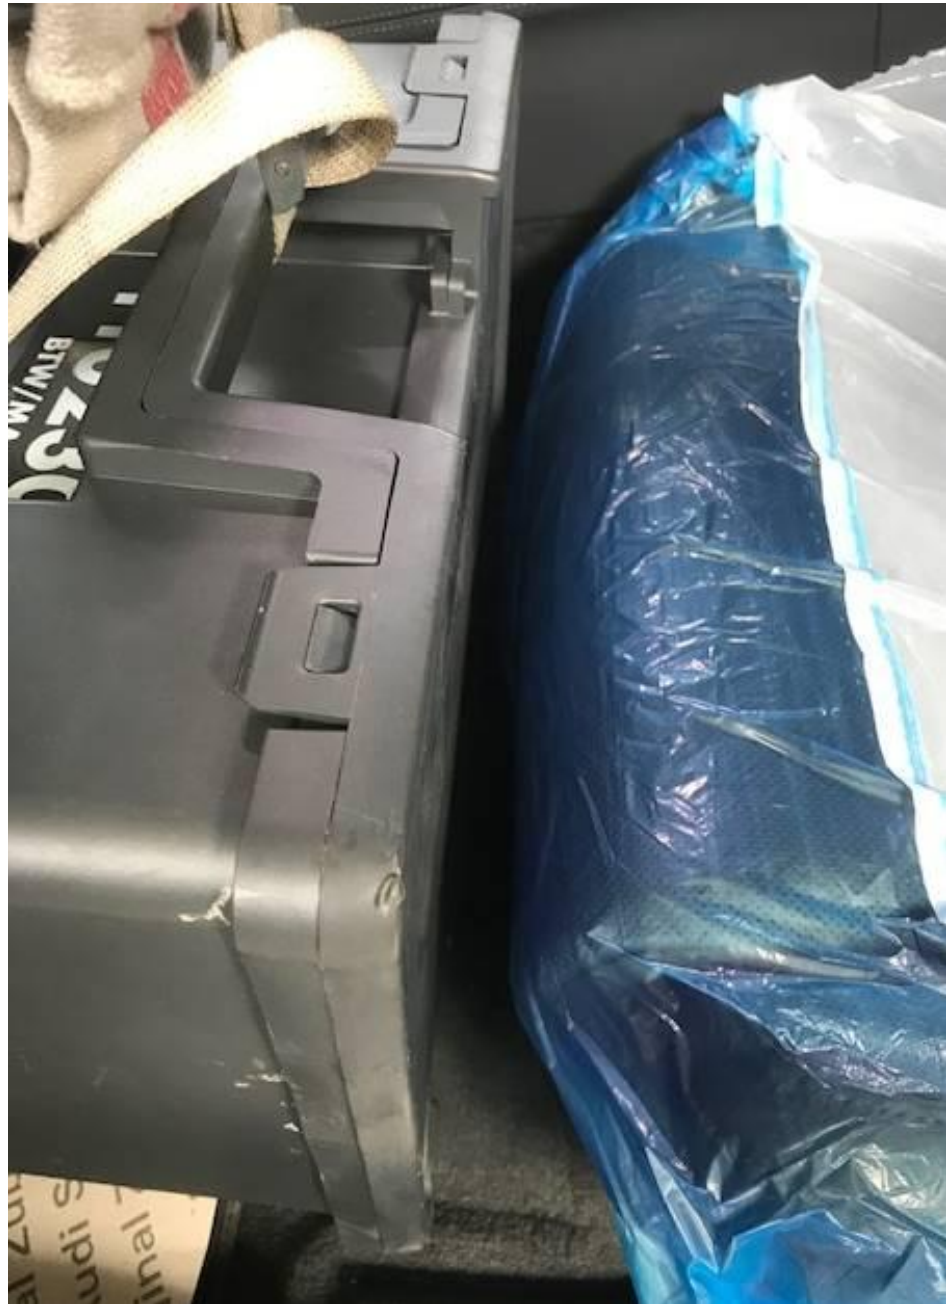
**Figure 3.** Plastic foil protection for the seat.

7. Apply plastic foil to make sure the tool kit cannot scrape against the seat (Figure 3).
