## Technical Service Bulletin

| <b>Topic</b> | 90 Gateway software update: yellow battery warning lamp + P0A1F00 |
| <b>Brand</b> | Audi |
| <b>Transaction No.</b> | 2078806/1 |

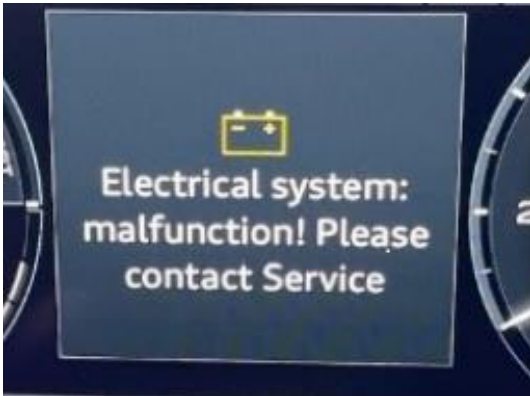
The customer complains that there is a yellow warning lamp in the instrument cluster (Figure 1) with a message about a battery management fault (12V system).

**Figure 1.** Yellow warning lamp.

The warning lamp disappears after switching the ignition off and then on again but may appear again.

- **P0A1F00:** Battery Energy Control Module Malfunction

Software issue in diagnostic interface control unit (DA0019).

**Software update to SW 0052 for the diagnostic interface control unit (DA0019):**

Please update the data bus diagnostic interface J533 (diagnostic address 0019) via SVM. To enter the SVM code, use “Flash” mode on the ODIS tester.

**ZGDOIP,19A027,19B027**
