## Technical Service Bulletin

| <b>Topic</b> | 93 e-tron GE various warning messages in the cluster, electric motor leaking P0AA600 |
| <b>Transaction No.</b> | 2073858/9 |
| <b>Release date</b> | Aug 19, 2025 |

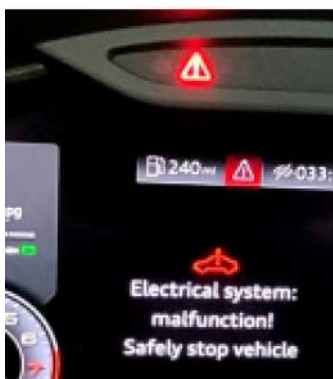
- A Drive System/Electrical System Malfunction message (Figure 1) appears in the instrument cluster; the warning may not be present at the time of inspection.

**Figure 1.** Warning lamp associated with message.

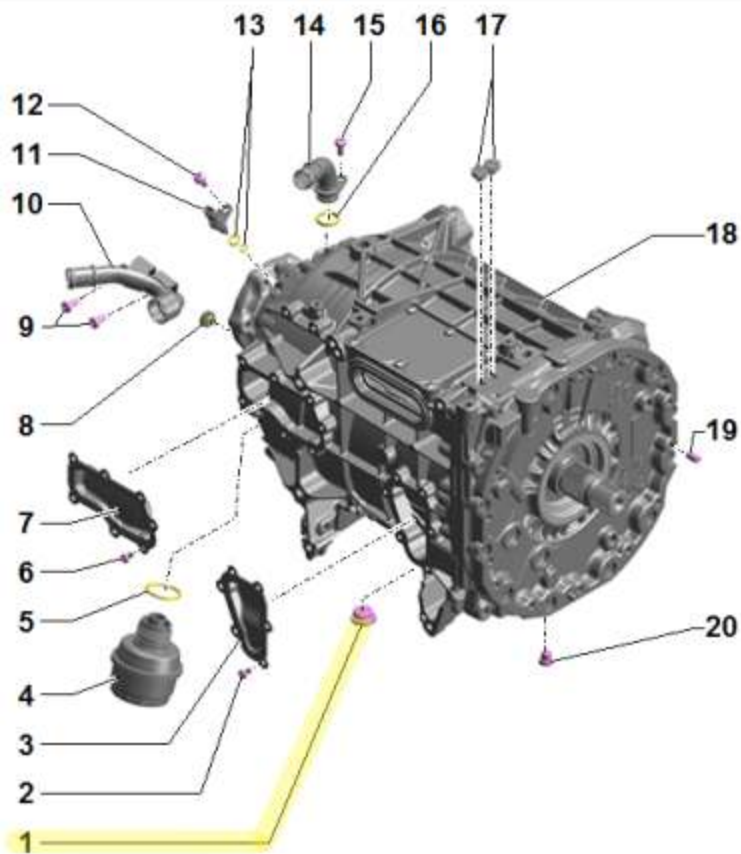
**Figure 2. (1) Drain plug.**

**Rear axle (Figure 2):**

Drip container is overflowing:

- Coolant leaking from active chamber.

Drip container is empty:

- Coolant leaking from active chamber, particularly on vehicles with low mileage.

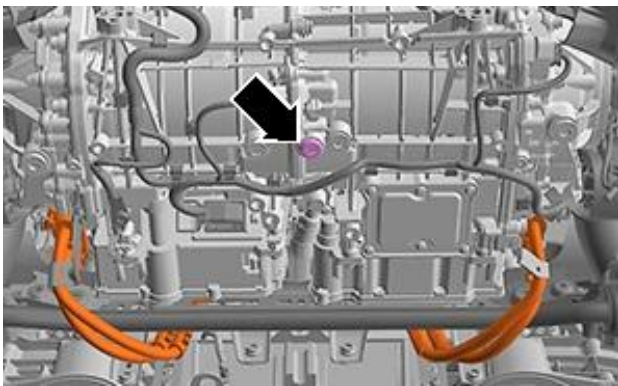
**Dual motor rear axle (refer to Figure 4):**

**Figure 4.** The drain plug is located between the two rear electric motors (see arrow).

A few milliliters of coolant leakage is not an issue from a technical perspective.
