## Technical Service Bulletin

| <b>Topic</b> | 27 Service info: A5/Q5 - Charging system: fault! AC charging not possible - U01E400 in diagnostic address 0019 |
| <b>Transaction No.</b> | 2078875/1 |
| <b>Release date</b> | Aug 1, 2025 |

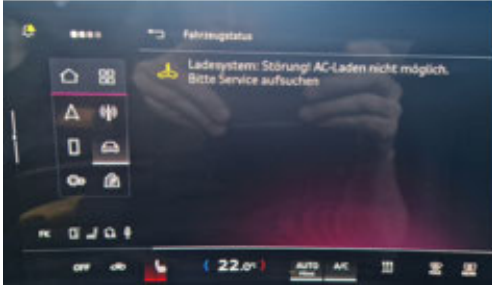
The message "Charging system: fault. AC charging not possible. Please contact workshop" is shown in the instrument cluster, although the vehicle has a combustion engine.

**Figure 1.** A message appears in the instrument cluster.

This is a software-related issue during the vehicle start-up phase which may cause the message described above to be displayed in the instrument cluster in rare cases. It has no effect on the normal operation of the vehicle and the sporadic warning message usually doesn't appear after completely switching the ignition off and on again.

There is no reason to attempt any further repairs.
