## Technical Service Bulletin (TSB)

### Service 4WD Light Illuminated

| REFERENCE: | TSB: 03-007-25<br>GROUP: 03 - Differential And Driveline | Date: | September 3, 2025 | REVISION: | — |
| VEHICLES AFFECTED: | 2025 (WL) Jeep Grand Cherokee/Grand Cherokee L<br>This bulletin applies to vehicles built on or after December 13, 2024 (MDH 1213XX) and on or before February 11, 2025 (MDH 0211XX) equipped with Conv Diff Frt Axle W/Disconnect (Sales code DSM) and 3.6L V6 24V VVT Engine Upg I w/ESS (Sales Code ERC). | | | MARKET APPLICABILITY:<br><div><input checked="" type="checkbox"/> NA<input checked="" type="checkbox"/> MEA<br/><input type="checkbox"/> SA<input type="checkbox"/> IAP<br/><input type="checkbox"/> EE<input type="checkbox"/> CH</div><br><b>NOTE:</b> This bulletin applies to North America and Middle East & Africa markets. | |

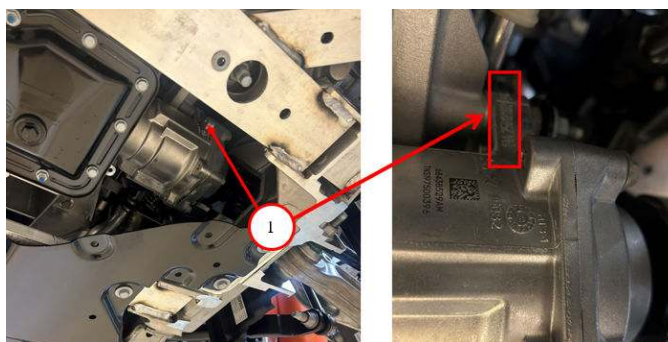
**Fig. 1**  
FAD housing

2. Locate the stamped serial number on the FAD housing [Fig. 1](#).

1 - Serial number location

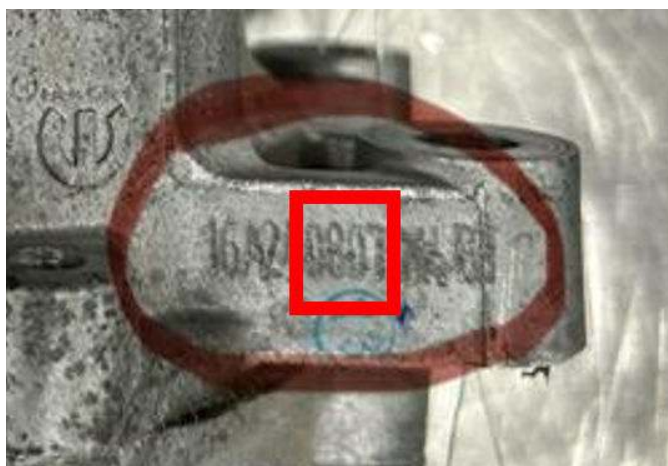
**Fig. 2**  
Serial Number

3. Are characters 6-9 of the serial number 0807 or 0806 [Fig. 2](#)?
  - YES>>> Proceed to [Step 4](#).
  - NO>>> This bulletin has been completed. Use Inspection LOP (08-46-34-92) to close the active RSU and proceed to [Step 5](#).

4. Replace the FAD assembly. Refer to the detailed service procedures available in DealerCONNECT/Service Library under: Service Info> 03 - Differential and Driveline / Actuator/Motor / Removal and Installation.
5. Install the front belly pan. Refer to the detailed service procedures available in DealerCONNECT/Service Library under: Service Info> 13 - Frame and Bumpers / Under Body Protection / Belly Pan / Installation.
6. Clear DTCs.
