## TECHNICAL SERVICE BULLETIN

### Illuminated MIL And/Or Powertrain Malfunction (Wrench) Indicator With Various Diagnostic Trouble Codes (DTCs)

**25-2385**

Ford  
2022 e-Transit

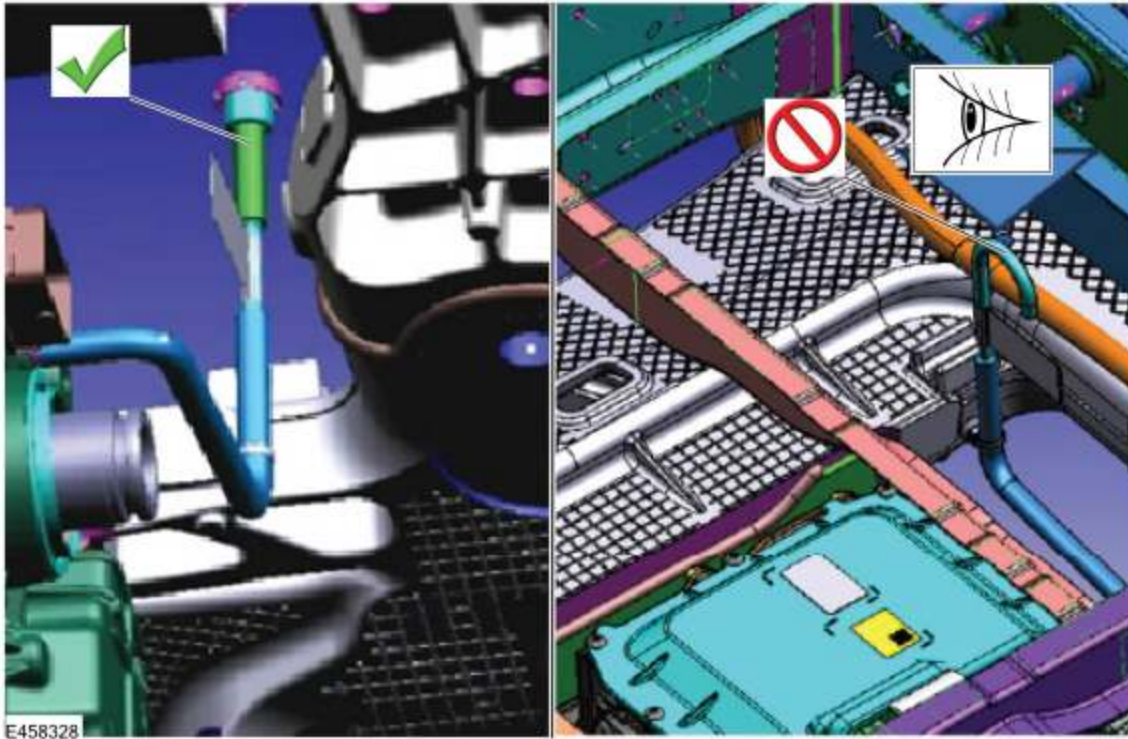
Figure 1

- Illuminated MIL and/or illuminated powertrain malfunction (wrench) indicator with DTCs P0711, P0A2B, P0A2D, P0A2C, P0712, P0713 stored in the SOBDMC.
- DTCs P0AA6, P1A10 stored in the IPC
- Equipped with early design vent assembly attached to rear electric drive assembly. Refer to Figure 1.

1. Raise vehicle to inspect the rear electric drive assembly unit vent. Refer to WSM, Section 100-02 > Jacking and Lifting.
2. Is the vehicle equipped with the rear electric drive assembly vent hose as shown in the image with the green check mark in Figure 1?

- (1). Yes - proceed to Step 4.
  - (2). No - proceed to Step 3.
3. Remove and discard the vent tube assembly and replace with updated part.
  4. Perform the "Drive Assembly Oil Draining and Filling". Refer to WSM, Section 302-02 > General Procedures.
  5. Clear DTCs.
