## Technical Service Bulletin (TSB)

### Rear Mid Range Radar (MRR) Bracket Revision

| REFERENCE: | TSB: 08-166-26<br>GROUP: 08 - Electrical | Date: | April 18, 2026 | REVISION: | — |
| VEHICLES AFFECTED: | 2025 (DT) RAM 1500 Pickup<br>This bulletin applies to vehicles built on or before April 30, 2025 (MDH 0430XX) equipped with Blind Spot And Cross Path Detection (Sales Code XAN). | | | MARKET APPLICABILITY:<br><div><input checked="" type="checkbox"/> NA<input type="checkbox"/> MEA<br/><input type="checkbox"/> SA<input type="checkbox"/> IAP<br/><input type="checkbox"/> EE<input type="checkbox"/> CH</div><br>NOTE: This bulletin applies to North America markets. | |

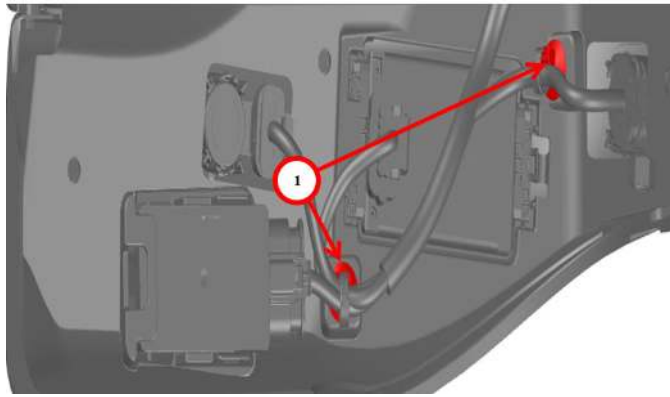
**Fig. 2**  
Release Wire Harness

1 - Wire Harness Retainers

3. Disengage the wire harness retainers [Fig. 2](#).

16. Engage the wire harness retainers [Fig. 2](#).

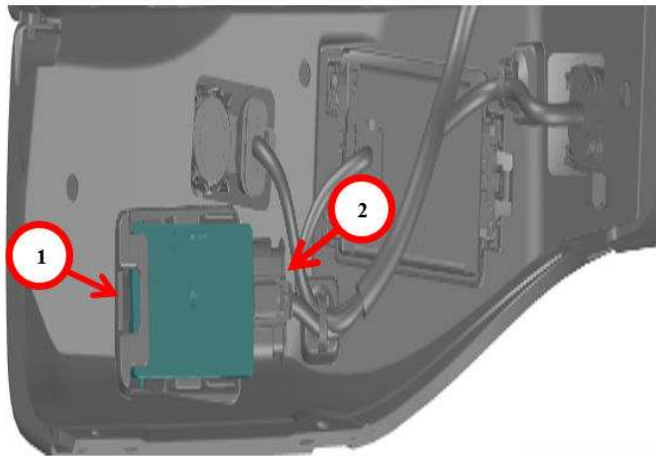
**Fig. 3**  
SPAAK Module

1 - SPAAK Shoe Retainer  
2 - SPAAK

4. Depress the shoe retainer to release and remove the Smart Phone As A Key (SPAAK) module [Fig. 3](#).

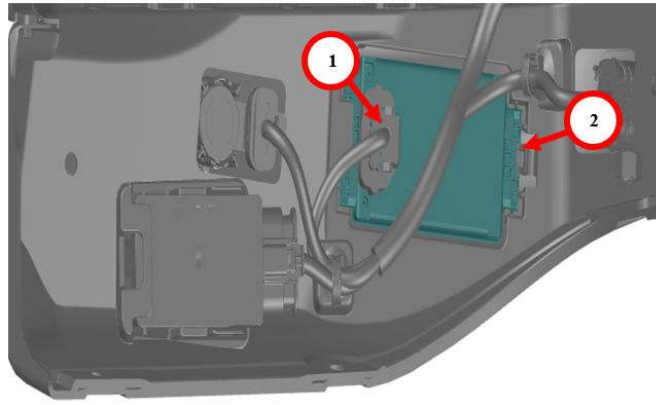
**Fig. 4**  
MRR Removal

1 - MRR

2 - MRR Shoe Retainer

5. Depress the shoe retainer to release and remove the MRR [Fig. 4](#).

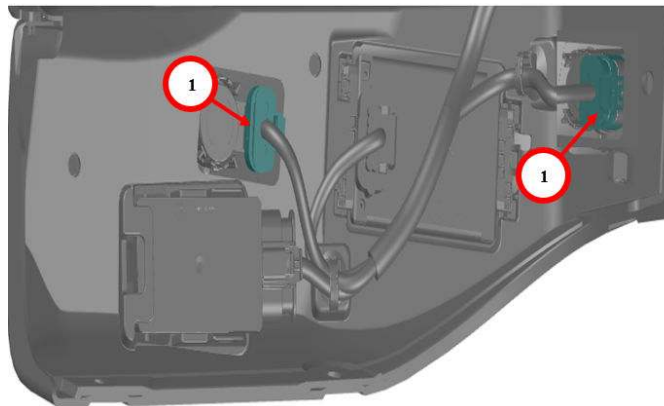
**Fig. 5**  
RPA Wire Harness Connector

1 - RPA Sensor Wire Harness Connectors

6. Disconnect the Rear Park Assist (RPA) sensor wire harness connectors [Fig. 5](#).

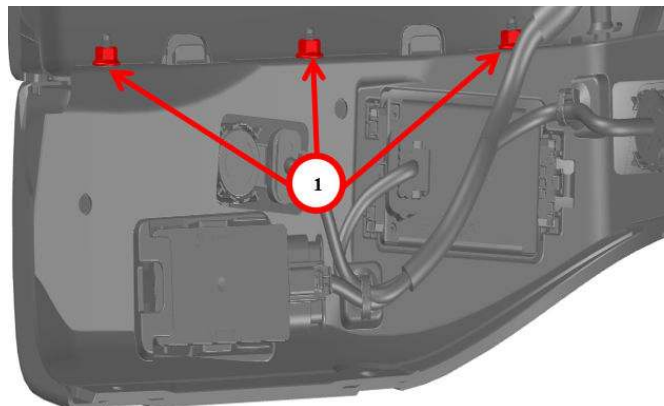
**Fig. 6**  
Loosen M6 Nuts

1 - M6 Nuts

7. Loosen the M6 nuts [Fig. 6](#).

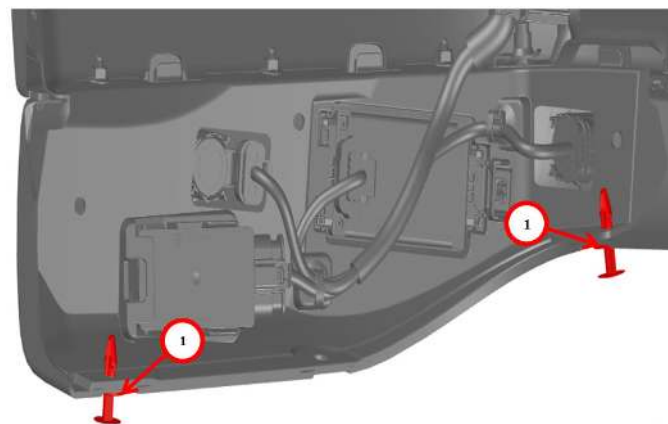
**Fig. 9**  
Push Pins

1 - Install Push Pins

10. Install two push pins [Fig. 9](#).
