## Technical Service Bulletin (TSB)

### Water In Fuel (WIF) Indicator Light

| REFERENCE: | TSB: 14-004-26<br>GROUP: 14 - Fuel System | Date: | April 16, 2026 | REVISION: | — |
| VEHICLES AFFECTED: | 2025 - 2026 (D2) RAM 3500 Pickup<br>2025 - 2026 (DJ) RAM 2500 Pickup<br>2025 (DD) RAM 3500 Cab Chassis<br>2025 (DP) RAM 4500/5500 Cab Chassis<br>This bulletin applies to the DD and DP vehicles built with a 6.7L I6 Cummins HO Turbo Diesel engine (Sales Code ETM) or a 6.7L I6 Cummins Turbo Diesel engine (Sales Codes ETN).<br>This bulletin applies to the D2 and DJ vehicles built on or before January 23, 2026 (MDH 0123XX) equipped with a 6.7L I6 Cummins HO Turbo Diesel engine (Sales Code ETM) or a 6.7L I6 Cummins Turbo Diesel engine (Sales Codes ETN). | | | MARKET APPLICABILITY:<br><div><input checked="" type="checkbox"/> NA<input type="checkbox"/> MEA</div> <div><input type="checkbox"/> SA<input type="checkbox"/> IAP</div> <div><input type="checkbox"/> EE<input type="checkbox"/> CH</div><br><b>NOTE:</b> This bulletin applies to the North America market. | |

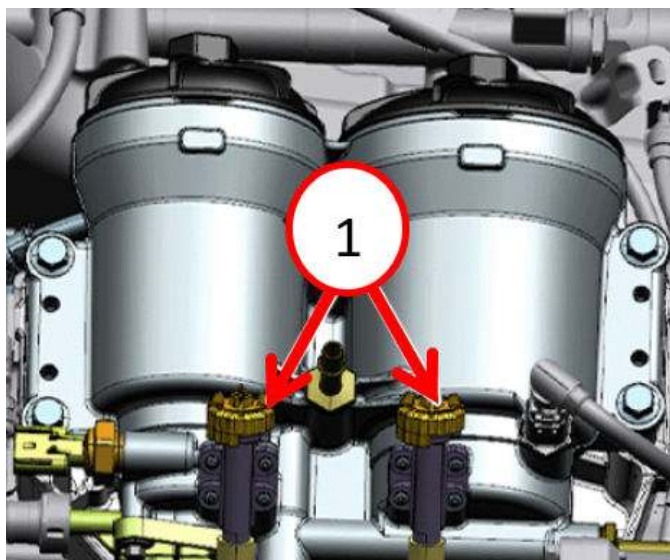
**Fig. 1**  
Water Separator

| CAUSE: | Persistent WIF Light caused by incomplete draining of the fuel filter housing. | | | | |

1 - Water Separator Drain Valves

1. Disconnect and isolate the negative battery cable(s). Refer to the detailed procedures available DealerCONNECT > Service Library> under: 08 - Electrical/Battery System/Standard Procedure.
2. Remove the left front wheelhouse splash shield. Refer to the detailed procedures available DealerCONNECT > Service Library> under: 23 - Body/Exterior/SHIELD, Splash/Removal and Installation.
3. **With engine not running**, Route the fuel drain hose to an appropriate container and rotate drain valves [Fig 1](#) one quarter turn counterclockwise to open it.

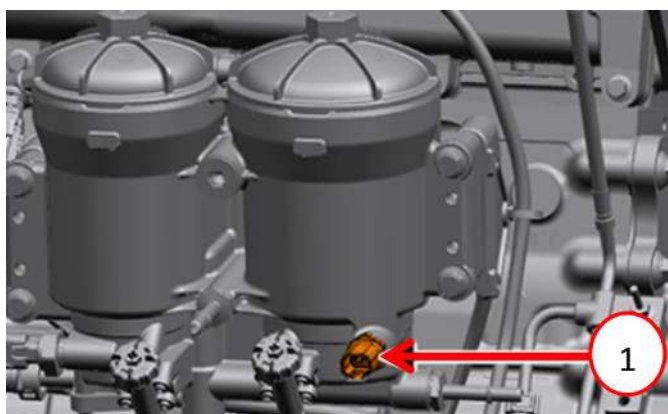
**Fig. 2**  
WIF Sensor

1 - WIF Sensor

5. Remove the WIF sensor [Fig 2](#).

6. Using the wiring diagrams, refer to DealerCONNECT > Service Library> Wiring > Powertrain > Engine > Fuel Delivery System - 6.7L. From the Terminal Extraction Kit or equivalent, remove the two terminals for the signal wire (G123) and the sensor ground (K914) from their original positions in the harness connector.

7. Swap the locations of G123 and K914.
8. Reassemble the harness connector.
9. Inspect the sensor body, threads and the sensor O-ring seal, **ONLY** replace the sensor if the body is damaged, the threads are damaged (stripped or hammered threads), or if the sensor O-ring seal is damaged (broken or cracked o-ring).

11. Thread the sensor back into the housing by hand.
12. Torque the sensor to 3.5 N.m (2.6 ft. lbs). Verify the WIF Sensor pins are now in a near vertical position.
