## TECHNICAL SERVICE BULLETIN

### Illuminated MIL And/Or Powertrain Malfunction (Wrench) Indicator With Various Diagnostic Trouble Codes (DTCs)

26-2167

Ford  
2022 e-Transit

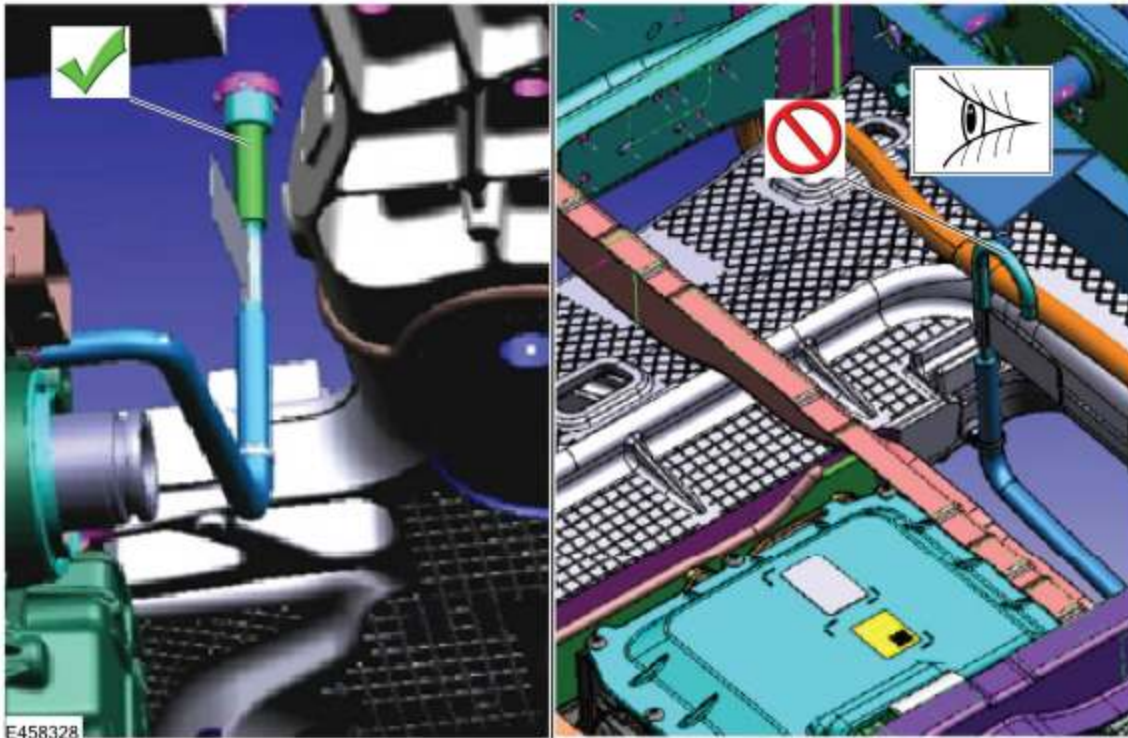
Figure 1

- Illuminated MIL and/or illuminated powertrain malfunction (wrench) indicator with DTCs P0711, P0A2B, P0A2D, P0A2C, P0712, P0713 and P1A10 stored in the SOBDMC.
- DTC P0AA6 stored in the BECM and/or IPC.
- Equipped with early design vent assembly attached to rear electric drive assembly. Refer to Figure 1.

**2.** Is the vehicle equipped with the rear electric drive assembly vent hose as shown in the image with the green check mark in Figure 1?

**3.** Remove and discard the rear electric drive assembly vent hose and replace with the updated part.
