# Service Bulletin

Bulletin No.: PIP6108

**Subject:** Diagnostic Tip PTO inoperative with DTC P251A

| Brand: | Model: | Model Year: | | VIN: | | Engine: | Transmission: |
|---|---|---|---|---|---|---|---|
| Chevrolet | Silverado<br>4500HD<br>5500HD<br>6500HD | 2019-2023 | | All | All | All | All |

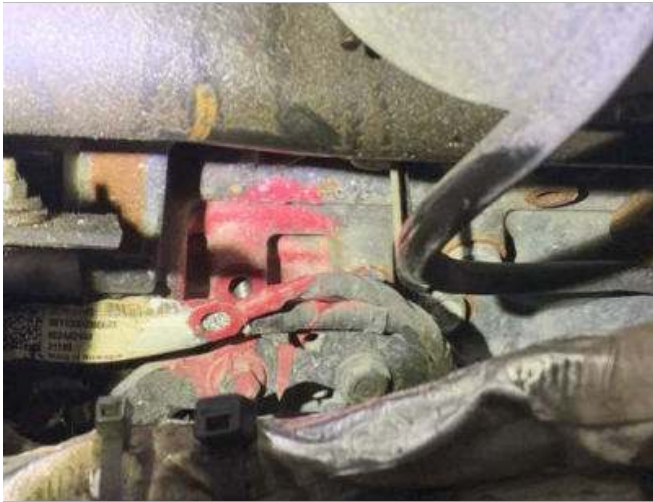
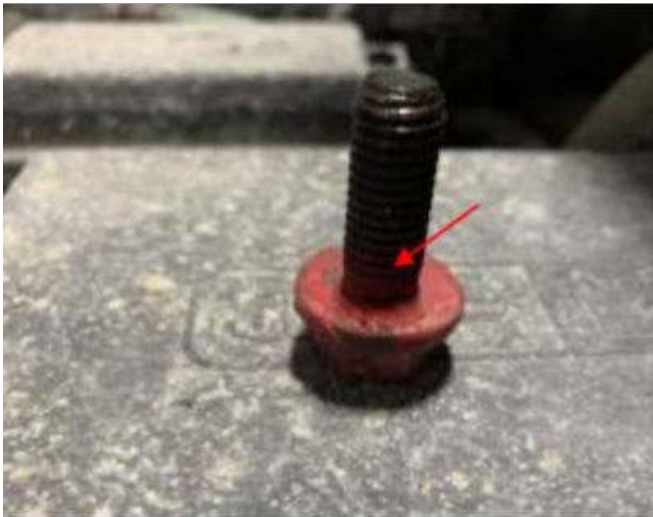
1. Check G120 which is the Main PTO ground.
  - a. G120 is on the left side of the engine.
  - b. Make sure the ground bolts is not too long and the ground eyelet has proper clamp load.
  - c. Inspect for the red anti-corrosion paint between block and eyelet and the eyelet and the bolt head review the pictures below. Clean and repair as necessary.

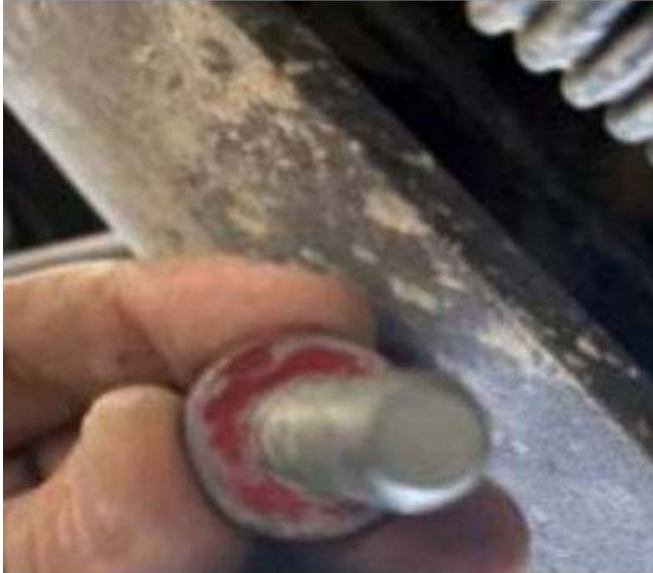
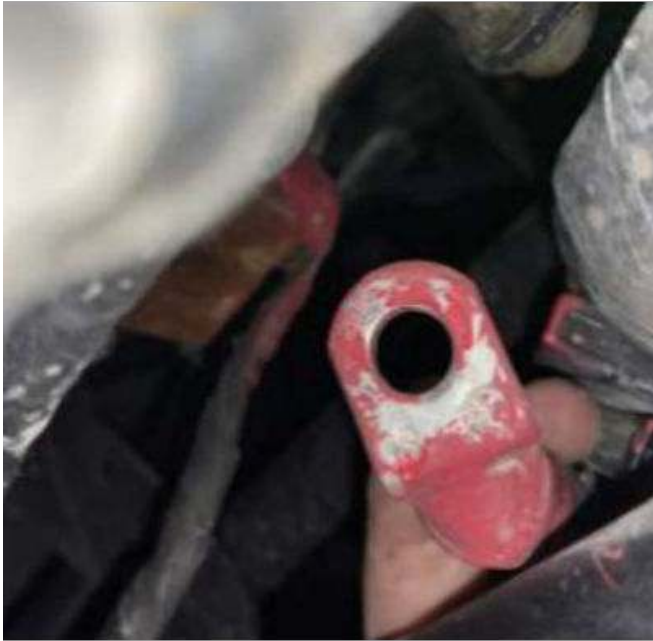
- Ground G108 is on the right front inner frame rail and G110 is on the right side of the engine.
- Inspect for the bolt being the proper length and not bottoming out, this will cause the bolt to be tight but no clamp load on the eyelet
- Inspect for the red anti-corrosion paint being between the eyelet and the engine block and the bolt and the eyelet please see the pictures below. Clean and repair as necessary.

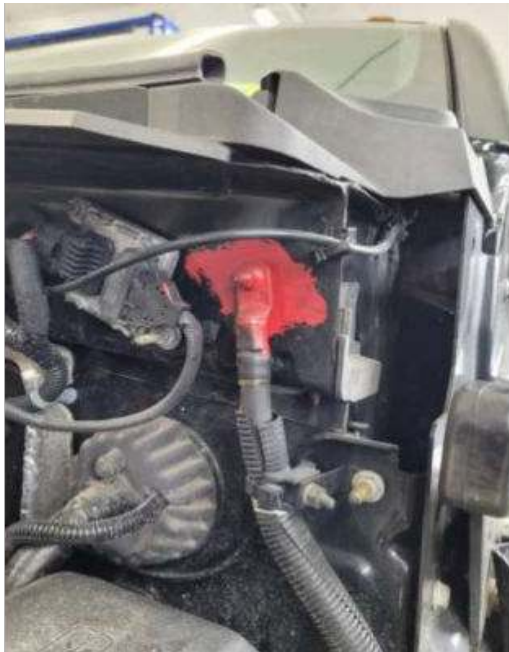
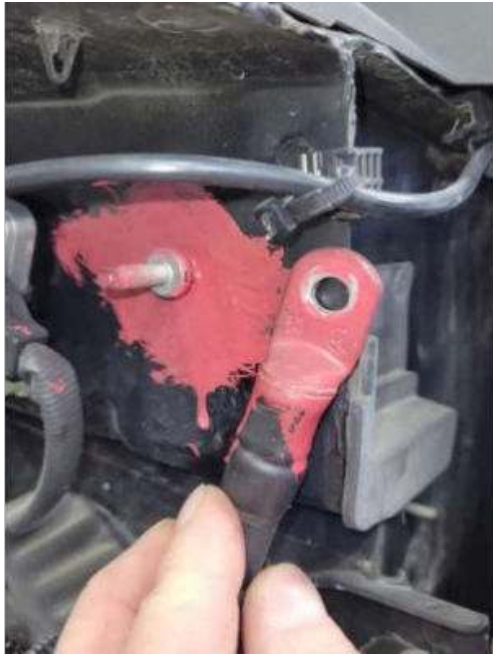
- Check G198 and G199 which is the main Body to left frame rail ground.
- G198 is on the body and G199 is on the left front frame rail
- Inspect for proper eyelet clamp load and for red anti-corrosion paint between the bolt head, eyelet and the engine block or body stud. Please see the below pictures. Clean and repair as necessary.
