## Technical Service Bulletin (TSB)

### Loss Of Cabin Heating

| REFERENCE: | TSB: 08-171-26<br>GROUP: 08 - Electrical | Date: | April 21, 2026 | REVISION: | — |
| VEHICLES AFFECTED: | 2025 - 2026 (D2) RAM 3500 Pickup<br>2025 - 2026 (DD) RAM 3500 Cab Chassis<br>2025 - 2026 (DJ) RAM 2500 Pickup<br>2025 - 2026 (DP) RAM 4500/5500 Cab Chassis<br>This bulletin applies to vehicles built on or before November 24, 2025 (MDH 1124XX). | | | MARKET APPLICABILITY:<br><div><input checked="" type="checkbox"/> NA<input type="checkbox"/> MEA</div> <div><input type="checkbox"/> SA<input type="checkbox"/> IAP</div> <div><input type="checkbox"/> EE<input type="checkbox"/> CH</div><br>NOTE: This bulletin applies to North America markets. | |

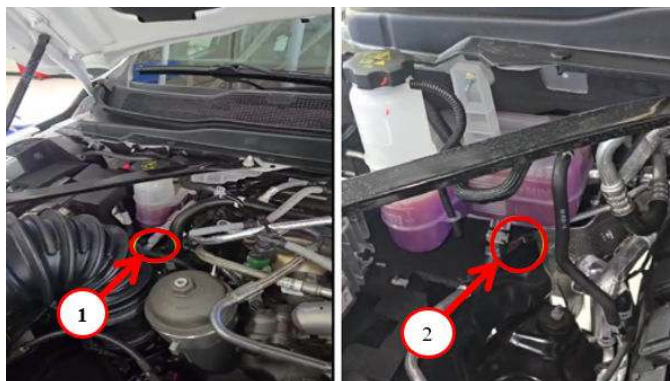
**Fig. 1**

D1673A Wire Harness Connector Location

1 - Gasoline Engine  
2 - Diesel Engine

1. Remove the front right wheelhouse splash shield. Refer to the detailed service procedures available in DealerCONNECT/Service Library under: Service Info> 23 - Body / Exterior / Shield, Splash, Front Wheelhouse / Removal.
2. Locate wire harness connector D1673A, which is a four way female connector underneath the coolant bottle [Fig. 1](#).

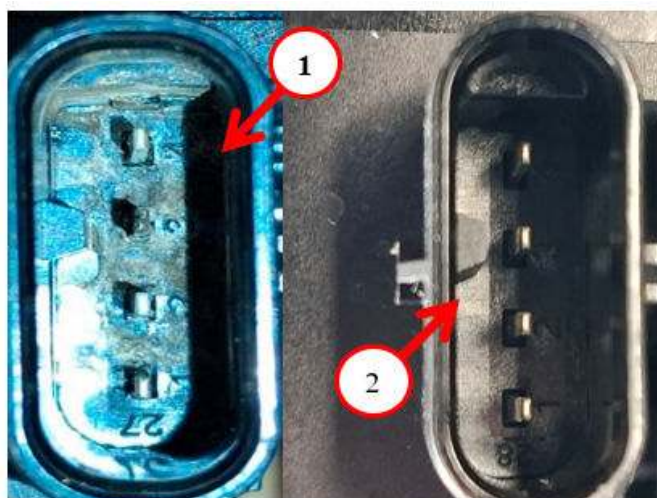
**Fig. 2**

3. Disconnect the D1673A wire harness from the coolant 3 way valves wire harness connector.
4. Inspect the wire harness connector terminals for evidence of corrosion [Fig. 2](#).

Wire Harness Connector Contamination Inspection

1 - Contaminated Wire Harness Connector  
2 - Uncontaminated Wire Harness Connector

5. Is there evidence of corrosion in the coolant 3 way valves wire harness connector?
  - YES>>> Proceed to [Step 7](#).
  - NO>>> Proceed to [Step 6](#).
