## Technical Service Bulletin (TSB)

### Global Telematics Box Module (TBM) Firmware Over The Air (FOTA) Update From R5N3 R5R1 R5N To 5T1

| REFERENCE: | TSB: 08-177-26<br>GROUP: 08 - Electrical | Date: | April 24, 2026 | REVISION: | – |
| VEHICLES AFFECTED: | 2026 (LB) Dodge Charger<br>This bulletin applies to vehicles equipped with Global Telematics Box Module (Sales Code RDG). | | | MARKET APPLICABILITY:<br><div><input checked="" type="checkbox"/> NA<input type="checkbox"/> MEA<br/><input type="checkbox"/> SA<input type="checkbox"/> IAP<br/><input type="checkbox"/> EE<input type="checkbox"/> CH</div><br>NOTE: This bulletin applies to the North America market. | |

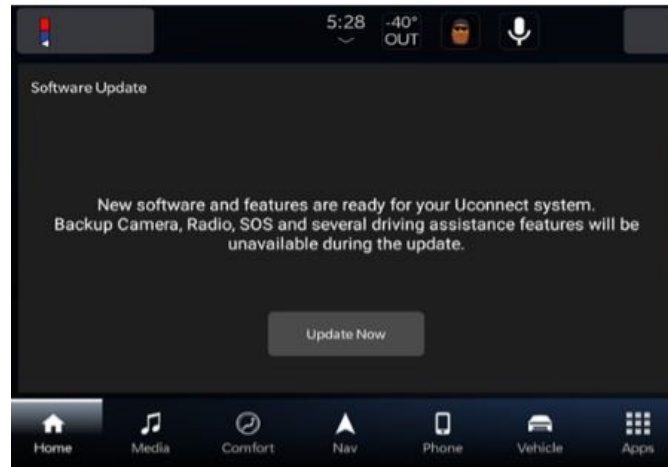
**Fig. 1**

**Software Acceptance Screen**

1. The vehicle needs to be in 'Park'. The ignition needs to be in the off position.
2. If the customer selects "Update Now" [Fig.1](#) they can shut off the vehicle and leave. The update will be completed automatically.

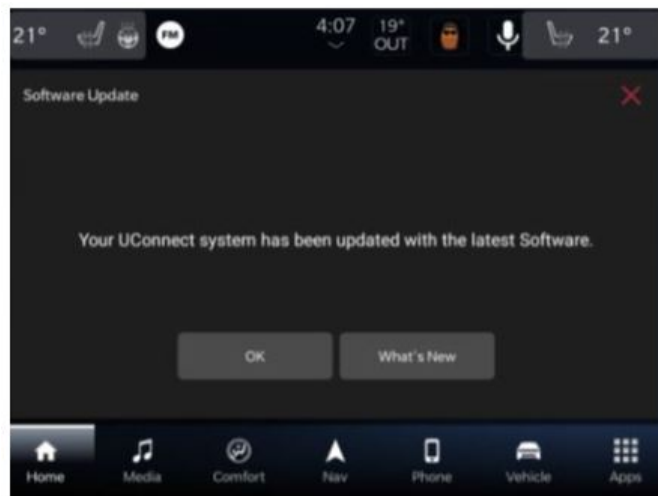
**Fig. 2**

**Software Update Confirmation Screen**

3. Upon completion of update, the radio will display a confirmation message [Fig. 2](#).
