## STAR ONLINE PUBLICATION

**Case Number:** S2609000006

**Symptom:** P000B Bank 1 Cam 2 Position Slow Response - Malfunction Indicator Light (MIL) - Check Engine Light (CEL)

**Models Affected:**

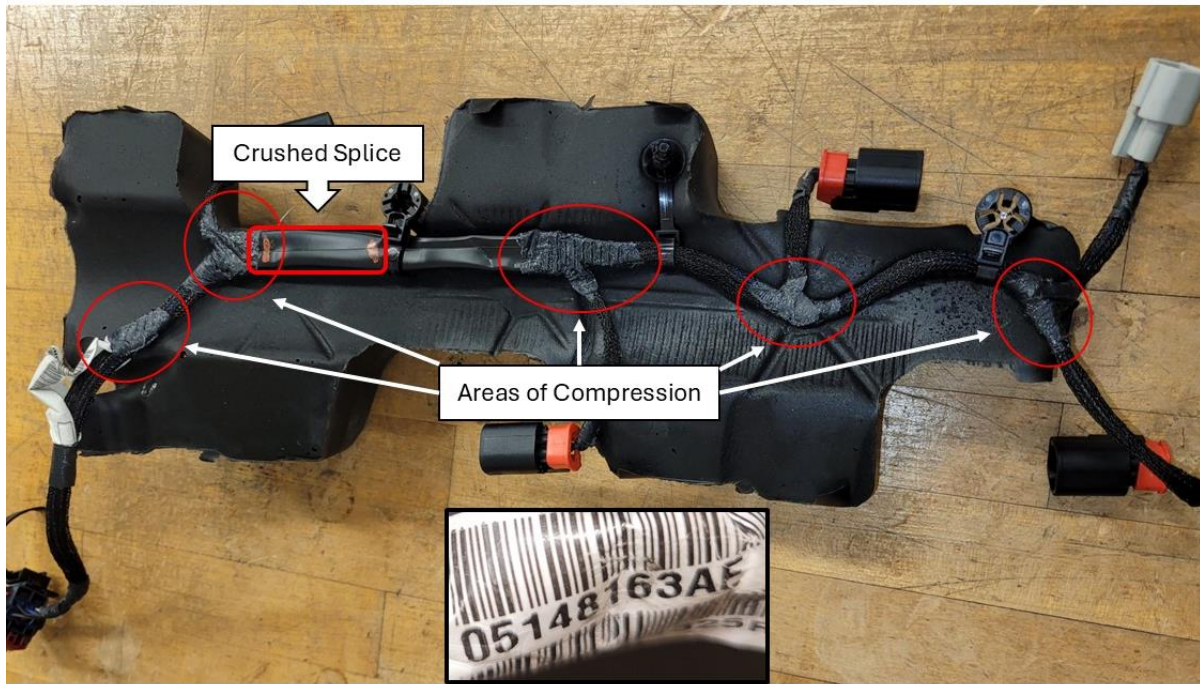
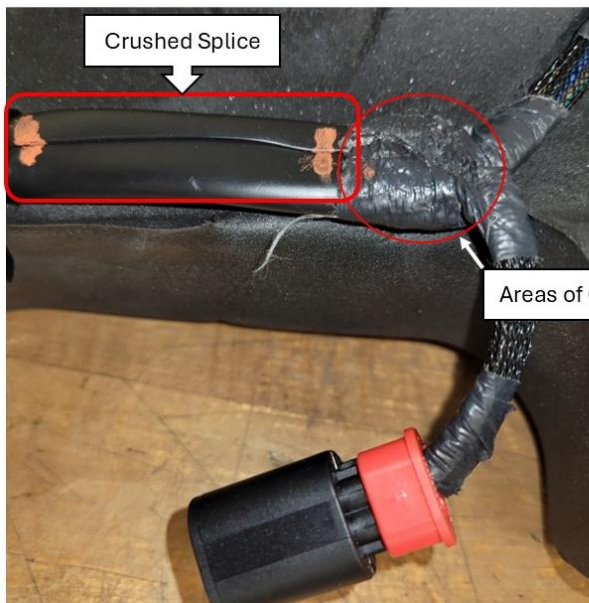
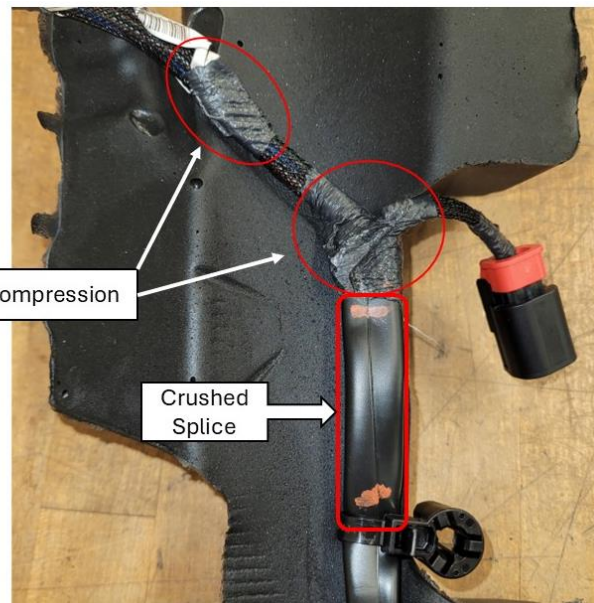
**Vehicle Issue:** The Intake Air Flow Module (IAFM) Foam Engine Valley Cover, PN 53013735AB, does not allow for sufficient routing of the MDS solenoid jumper harness PN 05148163AE. The wire harness is being compressed by foam.

**Technician Observation:** Technician observed intermittent open in MDS solenoid jumper harness PN 05148163AE. The technician found one or more of the following Diagnostic Trouble Codes (DTCs) have set on the vehicle:

**Discussion:** Inspect vehicle for DTC's and determine if any of the listed faults are stored or active in the system. If it is found that one of these DTC's are present, inspect the MDS solenoid jumper harness PN 05148163AE for an intermittent open connection along the harness. Test continuity between the harness to ensure proper connection within the harness. If there is an intermittent open connection, the MDS solenoid jumper harness must be replaced.
