# TECHNICAL SERVICE BULLETIN

EC26-009

## ENGINE NO START WITH KEY SYSTEM ERROR AND DTC B2C20-24 STORED IN THE BCM

**APPLIED VEHICLES:** 2025 Murano (Z53)

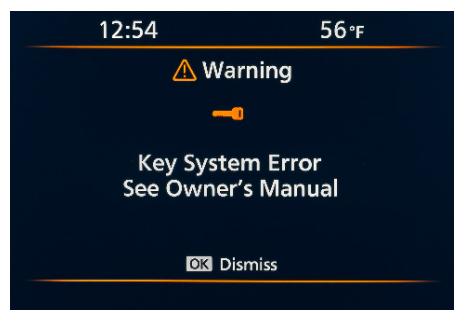
Figure 1

The customer states the engine will not start and “Key System Error” warning is displaying in the Information Display (Combination Meter) (Figure 1),

**HINT:** This DTC and warning message (Figure 1) may occur if the customer does not place the vehicle in Park Gear according to the Owner's Manual for shifter operation.

1. Confirm the current ECM part number.
2. Confirm the current TCM part number.
3. Reprogram the ECM, and then the TCM, if applicable.
4. Erase the DTCs.
