| Topic | Software Update BJB and HV ECUs Continental GT/GTC/Flying Spur 25MY (SC26 /06) |
| Campaign number | ED85 |

Software Update | BJB and HV ECUs | Continental GT/GTC/Flying Spur | 25MY  
(SC26/06)

Release date: Apr 2, 2026

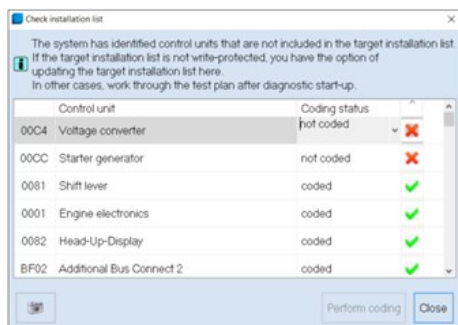
If a 'Check Installation List' pop-up appears, select 'close' (see below image)

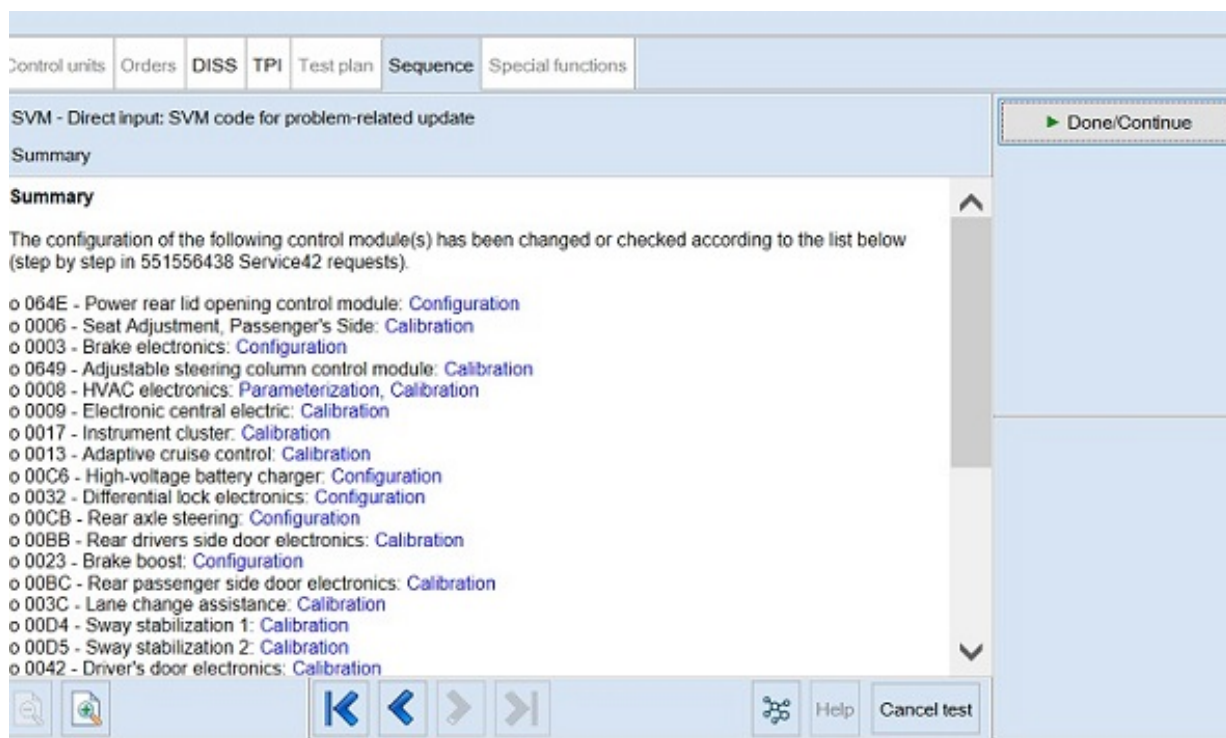
Fig 3

- a. From here, all control modules will be interrogated and the SVM action will take place.
6. Ensure that the diagnostic device remains connected for the duration of the update.
7. Follow all on-screen prompts until the program ends.
  - a. If you have a prompt stating there is no communication established with 00CC, select done/continue.
8. Follow the on-screen instructions to completion.
9. If you are presented with this screen (Fig 3) at the end of the update, the update was successful. Please continue to step 11.

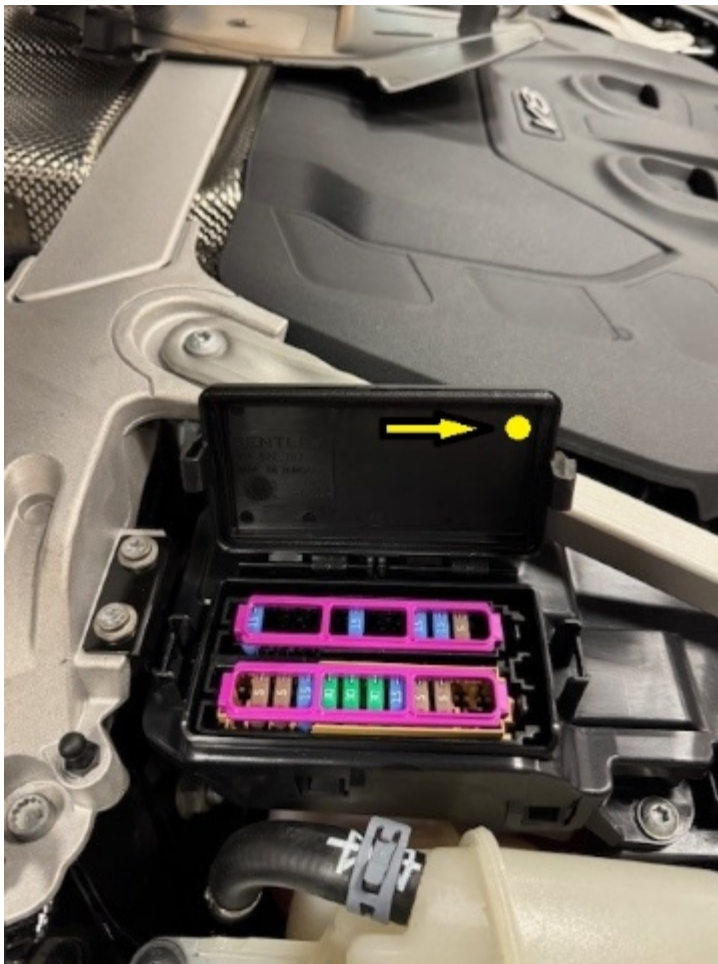
You must also add a yellow paint mark to the underside of the Fusebox cover as per the picture below.
