# Service Alert

INFOTAINMENT CENTER DISPLAY AND CONNECTED VEHICLE  
IMPROPER OPERATION

Service Alert No.: SA-015/26

2026 CX-5 (KM)

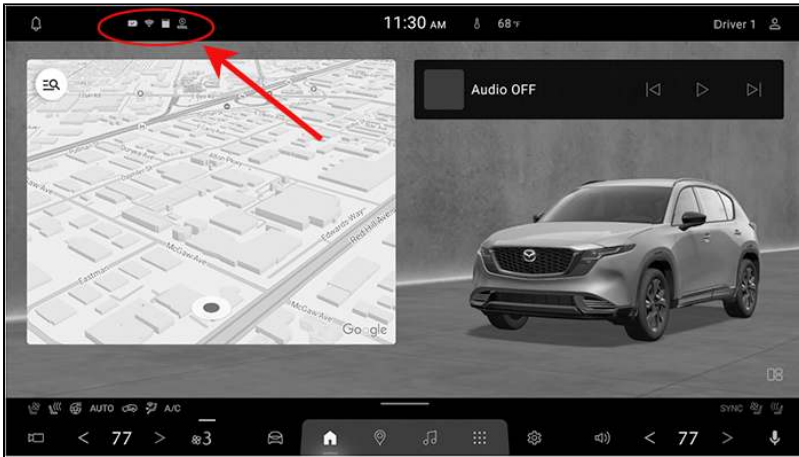
1. Intermittent Globe with a slash icon

- The Globe with Slash icon indicates that communication between the Cockpit Domain Controller (CDC) and the Data Communication Module (DCM) has not yet been completed.
  - This communication may take up to 90 seconds to complete. During this time, some Mazda Connect 3 functions, such as Google Assistant, will not be available.
  - Once communication is complete, the Globe with Slash icon will be replaced by the reception icon, as shown below.

- If communication between the CDC and DCM does not complete within 90 seconds, the system has experienced an interruption. Advise the customer that Mazda is aware of the condition and is currently working on a resolution. As soon as a resolution becomes available, this Service Alert will be promptly updated and re-released.
  - **NOTE:** Vehicle driving operation is not affected during this condition.

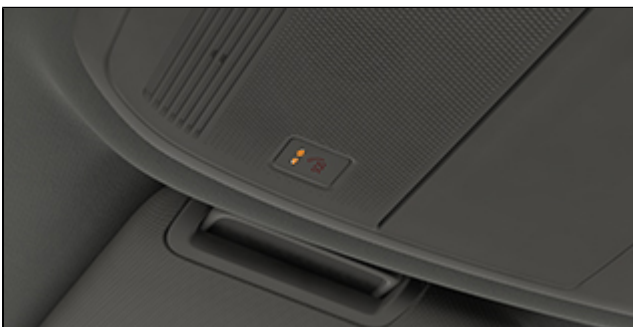
## 2. Beep sound near the SOS button and SOS button amber or red LED

- This condition is related to Item 1 above. Advise the customer that Mazda is aware of the condition and is currently working on a resolution. As soon as a resolution becomes available, this Service Alert will be promptly updated and re-released.

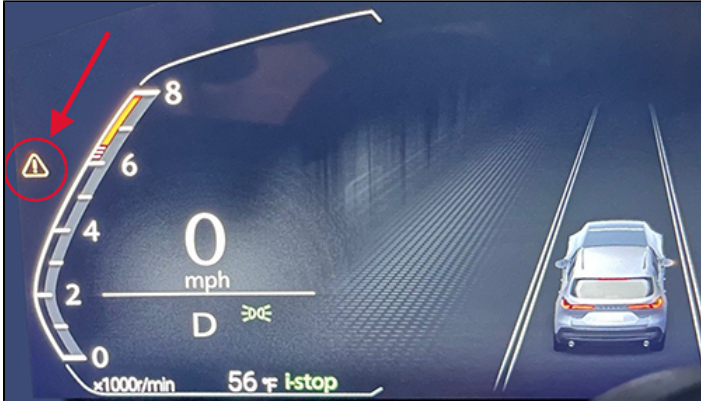
## 3. Instrument Cluster Master Warning Light may be illuminated

- Emergency Call Unit Malfunction Notification
  - Center Display Home screen --> All Apps --> Maintenance --> Notifications
- This condition is related to Item 1 above. Advise the customer that Mazda is aware of the condition and is currently working on a resolution. As soon as a resolution becomes available, this Service Alert will be promptly updated and re-released.

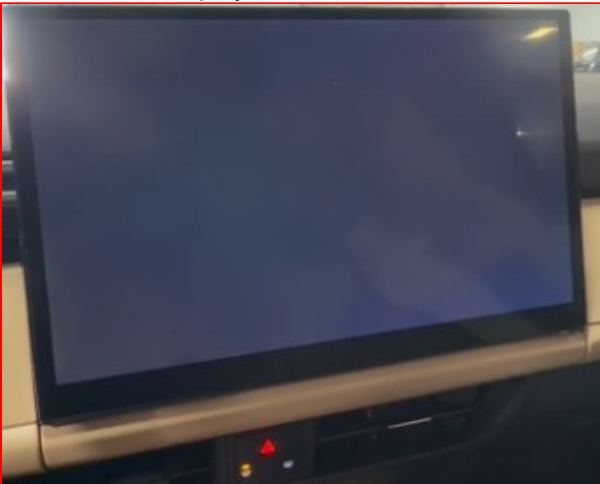
## 4. The center display screen is blank

- This condition is related to Item 1 above. Advise the customer that Mazda is aware of the condition and is currently working on a resolution. As soon as a resolution becomes available, this Service Alert will be promptly updated and re-released.

**NOTE:** The rear view camera display while in "Reverse" remains operational during this condition.

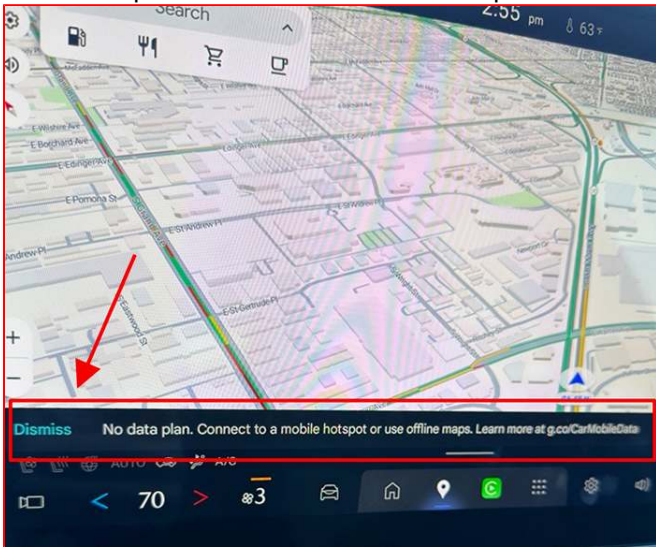
5. No data plan. Connect to a mobile hotspot or use offline maps. learn more at [g.co/CarMobileData](https://g.co/CarMobileData) message

- This message is incorrect.
- It does not affect system operation.
- Dismissing the message may temporarily clear it.
- Please ignore this message at this time.
- This condition is related to Item 1 above. Advise the customer that Mazda is aware of the condition and is currently working on a resolution. As soon as a resolution becomes available, this Service Alert will be promptly updated and re-released.

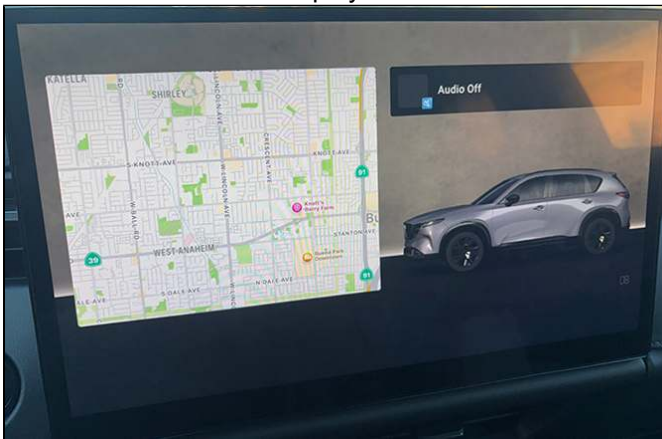
7. Infotainment Center Display Home Screen Partial Boot Up

- Top icons are not displayed.
- Bottom climate controls are not displayed.
- Google Voice is inoperative.
- Advise the customer that Mazda is aware of the condition and is currently working on a resolution. As soon as a resolution becomes available, this Service Alert will be promptly updated and re-released.

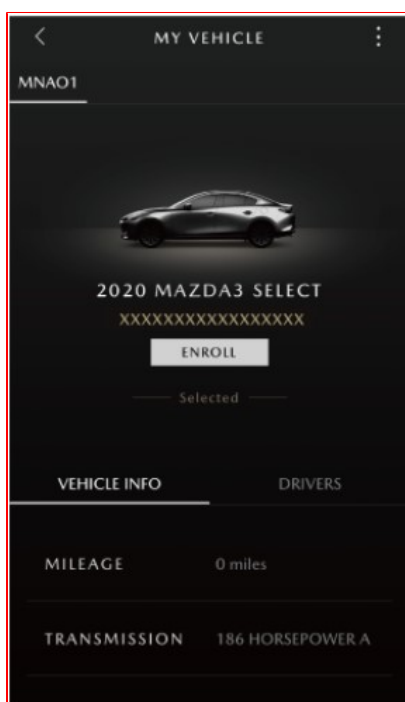
#### 8. No Connected Vehicle One-Time Passcode (OTP)

- The MyMazda App OTP request is sent; however, the vehicle's center display does not display the OTP.
- This condition is related to Item 1 above. Advise the customer that Mazda is aware of this condition and is currently working on a resolution. Once a resolution becomes available, this Service Alert will be promptly updated and re-released.
