# Service Alert

INFOTAINMENT CENTER DISPLAY AND CONNECTED VEHICLE  
IMPROPER OPERATION

Service Alert No.: SA-015/26

2026 CX-5

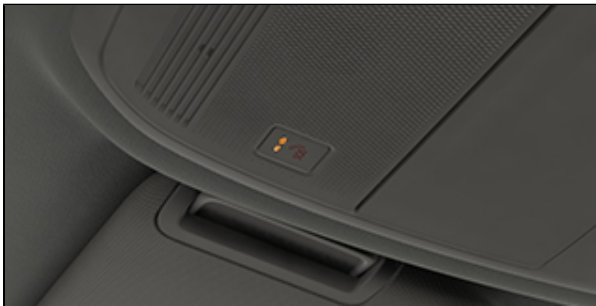
## 2. Beep sound near the SOS button and SOS button amber or red LED.

- This condition is related to Item 1 above. Advise the customer that Mazda is aware of the condition and is currently working on a resolution. As soon as a resolution becomes available, this Service Alert will be promptly updated and re-released.

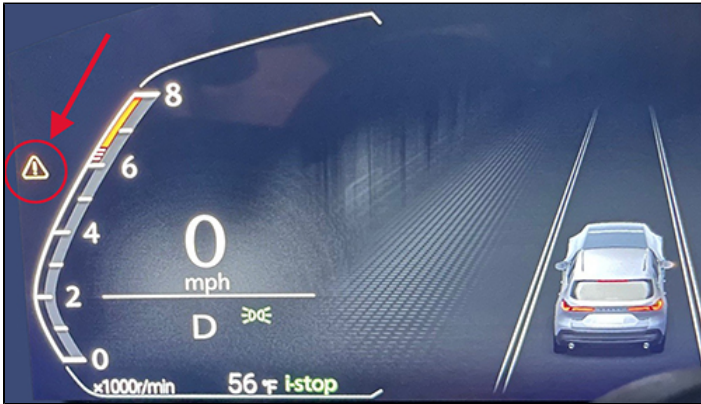
3. Instrument Cluster Master Warning Light may be illuminated.

- Emergency Call Unit Malfunction Notification.
  - Center Display Home screen --> All Apps --> Maintenance --> Notifications
- This condition is related to Item 1 above. Advise the customer that Mazda is aware of the condition and is currently working on a resolution. As soon as a resolution becomes available, this Service Alert will be promptly updated and re-released.

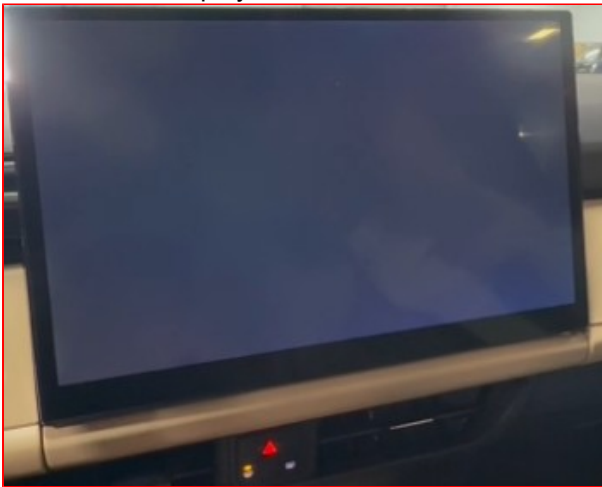
4. The center display screen is blank.

- This condition is related to Item 1 above. Advise the customer that Mazda is aware of the condition and is currently working on a resolution. As soon as a resolution becomes available, this Service Alert will be promptly updated and re-released.

**NOTE:** The rear view camera display while in "Reverse" remains operational during this condition.

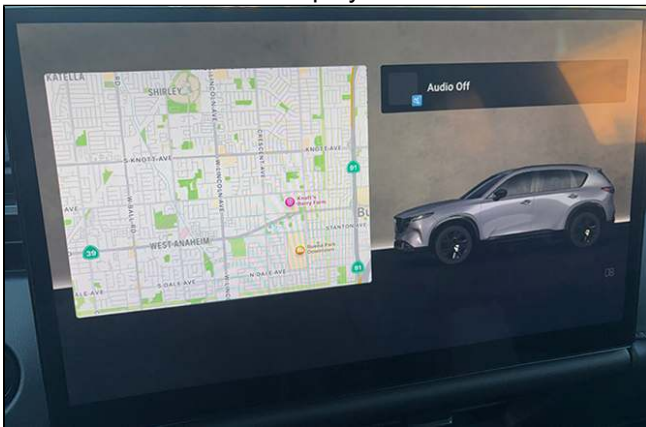
7. Infotainment Center Display Home Screen Partial Boot Up.

- Top icons are not displayed.
- Bottom climate controls are not displayed.
- Google Voice is inoperative.
- Advise the customer that Mazda is aware of the condition and is currently working on a resolution. As soon as a resolution becomes available, this Service Alert will be promptly updated and re-released.

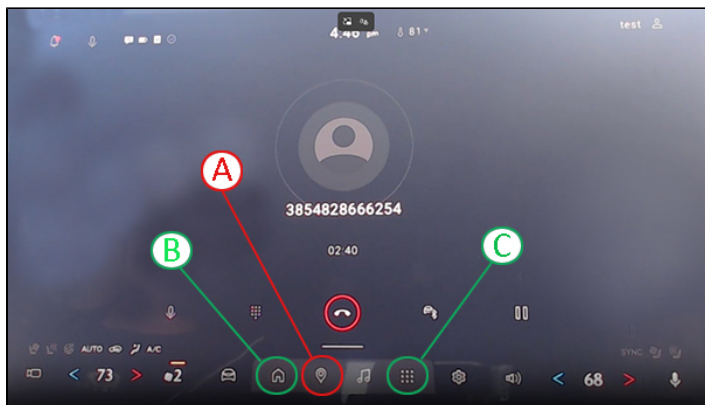
9. During a Bluetooth® phone call, tapping the navigation icon (A) does not launch Google Maps.

- This is normal system operation.
  - Google Maps is available during a Bluetooth® phone call:
    - Tap the [HOME] button (B) on the navigation bar, then tap the [Map Widget].
    - Tap the [All Apps] button (C) on the navigation bar, then select [Google Maps].

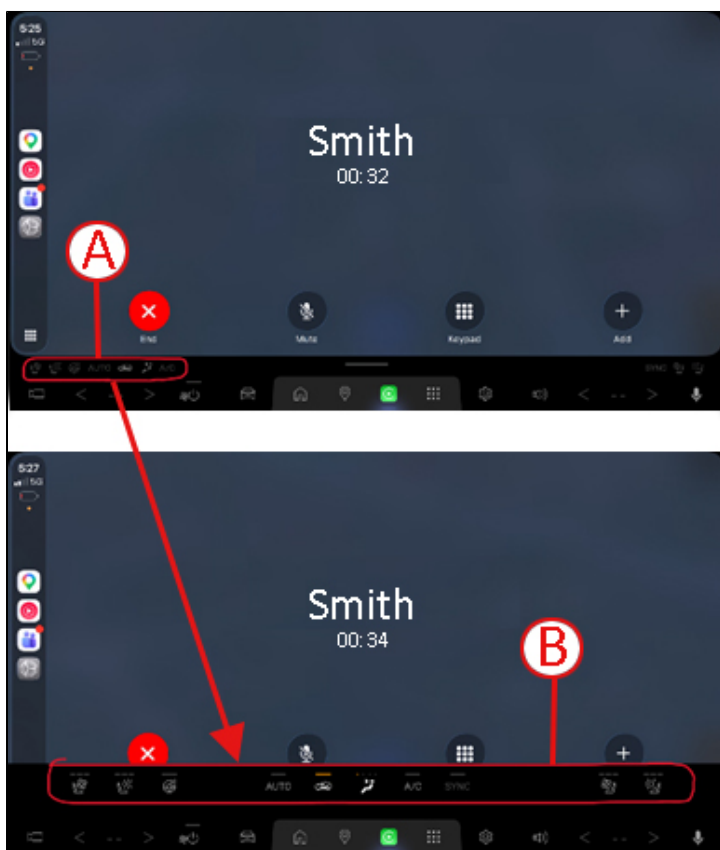
10. During an Apple CarPlay phone call, the Climate Control full-screen menu cannot be accessed. This is normal system operation.

- The Climate Control is available during a Apple Carplay phone call by selecting the area above the menu bar (A), then the Climate Control quick menu (B) will be displayed.

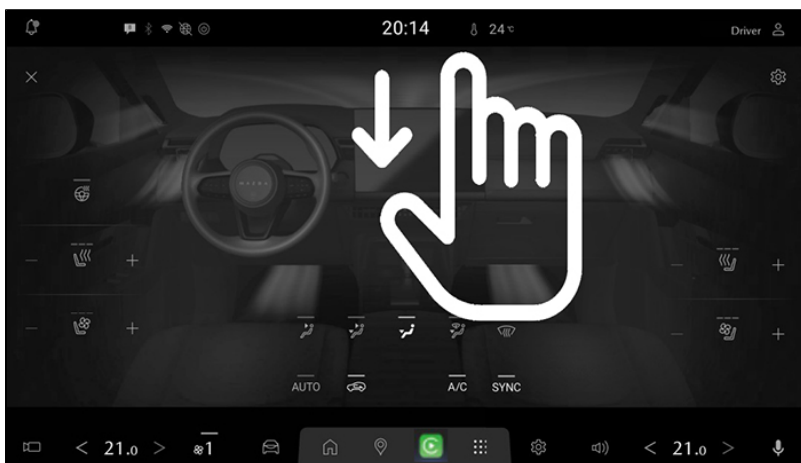
11. While the Climate Control screen is displayed in full screen, tapping the Apple CarPlay icon (A) does not launch Apple CarPlay.

- Because the screen priority is set to "Climate Control screen," it is not possible to switch directly to the CarPlay screen from the navigation bar.
- Use one of the following methods to return to the CarPlay screen:
  - Tap the "x" button (B) in the upper-left corner of the screen.
  - Tap the HOME button (C) on the navigation bar, then tap the CarPlay button on the navigation bar.

- Swipe downward on the screen.
