## Condition

| Model(s) | Year(s) | VIN Range | Vehicle Specific Equipment |
|---|---|---|---|
| A8 and Q8 | 2019 – 2026 | All | With PR Code:<br>9G8 |

| Revision | Date | Purpose |
|---|---|---|
| 18 | - | Revised header (Added model years)<br>Revised <i>Condition</i> (Added model table)<br>Revised <i>Warranty</i> (Updated labor operations) |

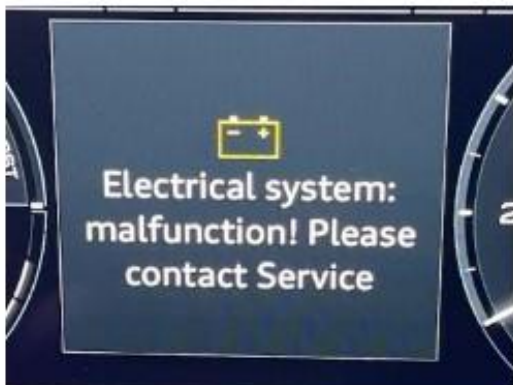
- The message “Electrical system: malfunction! Please contact Service” is displayed on the instrument cluster (Figure 1), in addition the battery symbol lights up in yellow or red.
- Yellow warning lamp related to the electrical system shown in the instrument cluster during driving.

**Figure 1.** Cluster Warning Message.

The following DTC is stored in the ECM, J623 (address word 0001):

- **DTC U046900:** Invalid data received from starter/generator control module (symptom 36564).

1. Hardware issue with belt-driven starter-alternator (diagnostic address 00CC).
2. Functional software issue with belt-driven starter-alternator (diagnostic address 00CC).

If the following DTC is shown in ODIS, replace the starter-alternator according to ETKA and check whether the complaint has been resolved:

- **B200096** – Faulty control module (active/static or passive/intermittent).

Seal the electrical connectors on the coolant temperature sender, the mating connector and the signal connector to belt-driven starter-alternator with leak-tight connector -T40348- or suitable workshop materials. Visually inspect components for moisture before assembly and clean electrical contacts if necessary.
