## Condition

| Model(s) | Year(s) | VIN Range | Vehicle Specific Equipment |
|---|---|---|---|
| A6 Sportback e-tron, S6 Sportback e-tron, Q6 e-tron, Q6 Sportback e-tron, SQ6 e-tron, and SQ6 Sportback e-tron | 2025 | All | 00A5 – Front sensor for driver assistance systems:<br><br>Software:<br><br>0250<br><br>0295 |

### Customer states:

Message in instrument cluster: “Charging connector still attached. Vehicle cannot be driven” although connector is not plugged in.

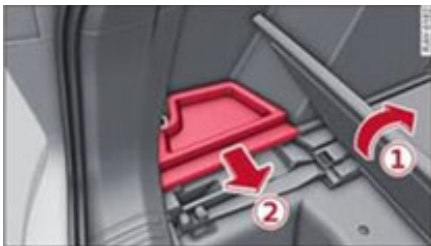
**Figure 1:** Fuse carrier installation location: luggage compartment on left, open cover.

1. Switch off the ignition
2. Remove fuse F39 (activation of charging flap and charging socket no.1) or F43 (activation of charging flap and charging socket no.2) for at least 10 seconds. The fuse is in the luggage compartment (see Figures 1 and 2).
3. Reinsert the fuse in its position.
