## Technical Service Bulletin

Transaction No.: **2078134/4**

93 Q4 e-tron - electric drive system warning lamp lights up / event memory entry:  
P0BBD00 in 008C

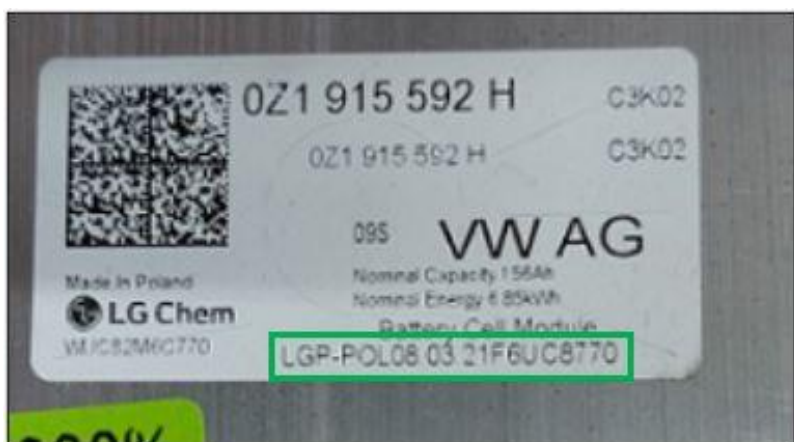
- Remove and open the high-voltage battery as per the Workshop Manual.
- Check the manufacturing date on type plate of the battery module to be renewed (see Figure 1):

- The consecutive production number (see Figure 1, highlighted in green) also includes the manufacturing date of the battery module. The manufacturing date of the battery module from the example (see image 1, highlighted green): LGP-POL **08.03.21** F6CUC8770 would therefore be **03/08/2021**.

**Figure 1.** Example image of a battery module type plate with production date: 08 03 21 (= 08.03.2021).

- If the battery module that must be replaced has a manufacturing date **prior to 12/04/2023 and** has one of the following part numbers: 0Z1.915.592.G, 0Z1.915.592.H, 0Z1.915.592.J, 0Z1.915.599.G, 0Z1.915.599.H, 0Z1.915.599.J, 0Z1.915.599.P, the battery module must be replaced according to the Workshop Manual/parts catalogue.

- If a battery module with a manufacturing date **from 12/04/2023 onwards** is installed, a *technical repair query* must be created.
