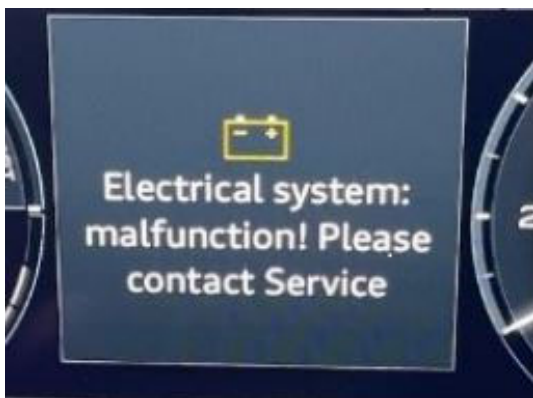
The customer complains that there is a yellow warning lamp in the instrument cluster (Figure 1) with a message about a battery management fault (12V system).

**Figure 1.** Yellow warning lamp.

- **P0A1F00:** Battery Energy Control Module Malfunction

Software issue in diagnostic interface control unit (DA0019).

**Software update to SW 0052 for the diagnostic interface control unit (DA0019):**

Please update the data bus diagnostic interface J533 (diagnostic address 0019) via SVM. To enter the SVM code, use “Flash” mode on the ODIS tester.

**ZGDOIP,19A027,19B027**
