## Technical Service Bulletin (TSB)

### Global Telematics Box Module (TBM)

### Firmware Over The Air (FOTA) Update

| REFERENCE: | TSB: 08-198-26<br>GROUP: 08 - Electrical | Date: | May 2, 2026 | REVISION: | – |

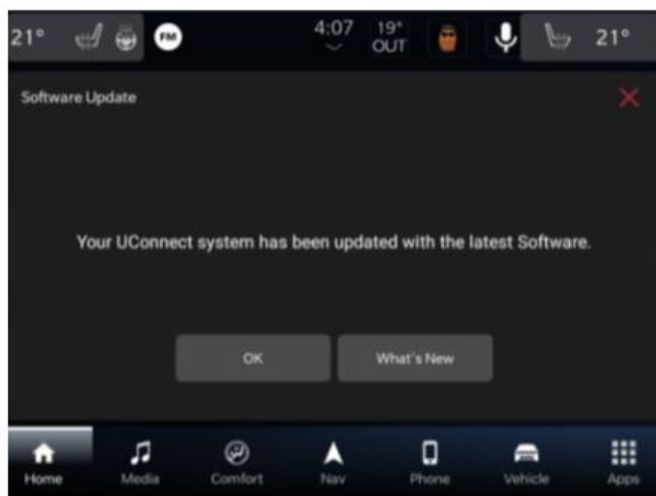
**Fig. 2**

Software Update Confirmation Screen

1. The vehicle needs to be in 'Park'. The ignition needs to be in the off position.
2. If the customer selects "Update Now" [Fig. 2](#) they can shut off the vehicle and leave. The update will be completed automatically.

3. Upon completion of update, the radio will display a confirmation message [Fig. 2](#).
