**Technical Service Bulletin (TSB)**  
**Global Telematics Box Module (TBM)**  
**Firmware Over The Air (FOTA) Update**

| REFERENCE: | TSB: 08-199-26<br>GROUP: 08 - Electrical | Date: | May 2, 2026 | REVISION: | – |

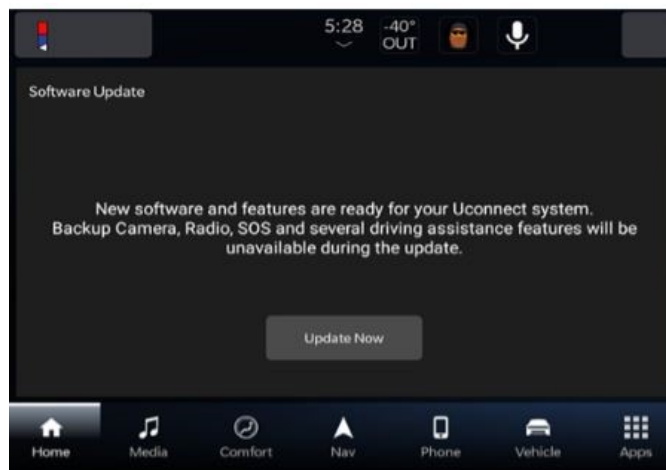
**Fig. 1**

Software Acceptance Screen

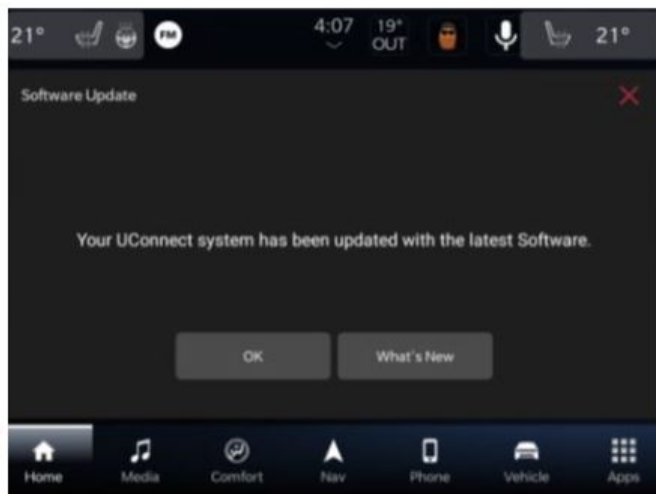
**Fig. 2**

Software Update Confirmation Screen

3. Upon completion of update, the radio will display a confirmation message [Fig. 2](#).
