## Technical Information

**35/26** ENU 9709

### Malfunction Indicator Light Active / Warning Message All-Wheel Drive Disturbed: Fault Memory Entry "U140500 - Terminal 15, Signal Implausible" in Various Control Units (35 / 26)

Model Line: **Cayenne (9YA / 9YB)**

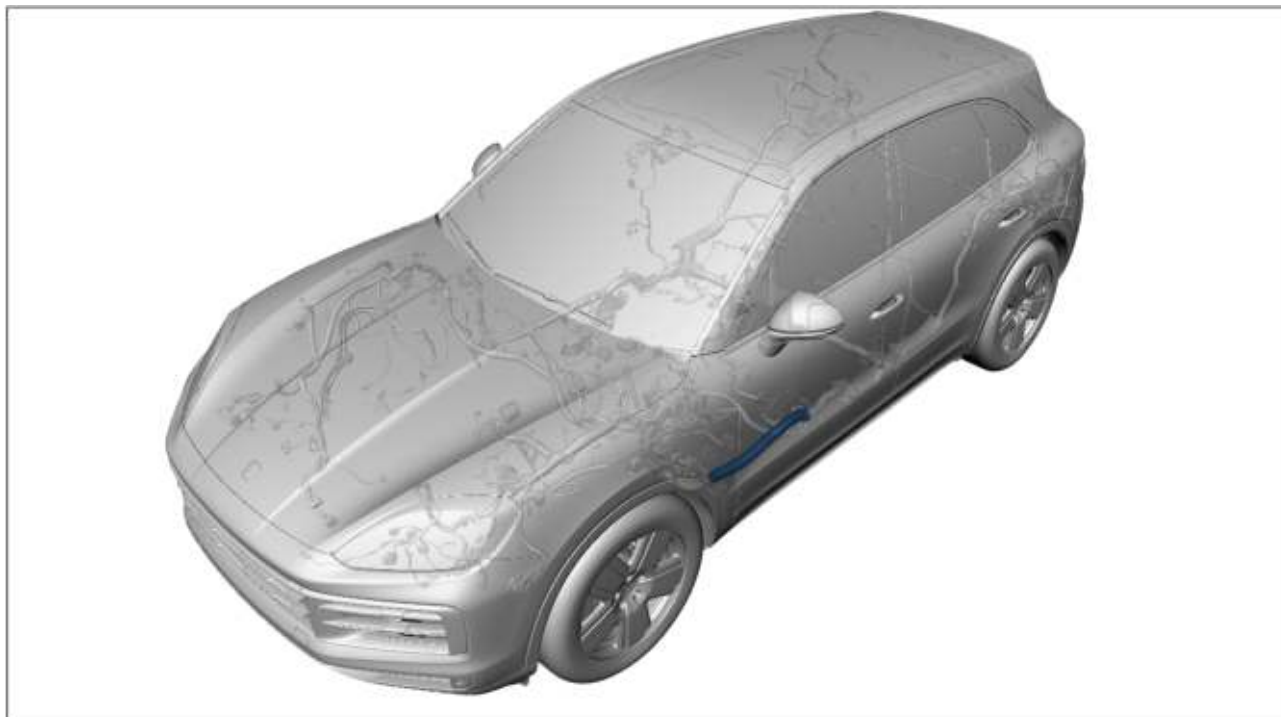
This complaint can be caused by unsealed splice connections on the main wire harness in the front left passenger compartment being corroded by condensation.

*Installation position: front left main wire harness (splice connections area)*

Action: In the event of a complaint and if the specified fault memory entry is stored, check the splice connections on the main wire harness in the front left passenger compartment for corrosion and repair if necessary.

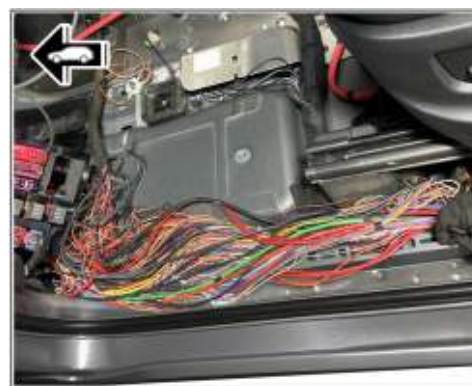
*Exposed main wire harness in the passenger compartment, front left.*

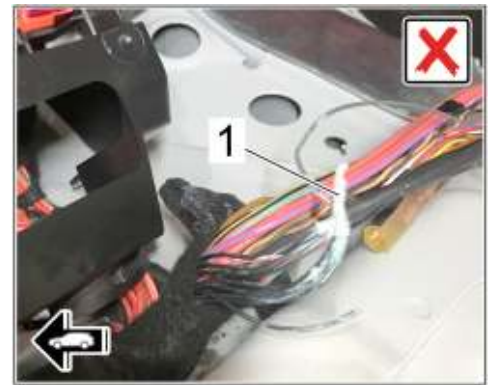
*Corroded splice connection  
(shown as an example)*

- Work Procedure: 1 Check splice connections on the exposed main wire harness for corrosion and ⇒ *Corroded splice connection (shown as an example) -1-* repair corroded splice connections if necessary.  
For work procedure, see: ⇒ *Workshop Manual '9797INA1 Information on electric crimp / splice connections'*
