# MIL ON P140018 - Loose Pin Tension at EGR Connector

**Service Category**   Engine/Hybrid System

**Applicability**

Some customers may experience a rough running engine with a MIL ON P140018 DTC. Upon further inspection, a loose C90/C27 connector pin at the EGR valve may be found. To correct this concern, please reference the repair section of this TSB.

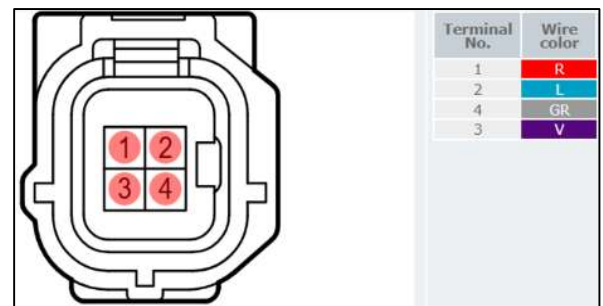
**Figure 1.**

2. Inspect C90/C27 connector at EGR valve and confirm if there are one or more loose terminals as seen in Figure 1. (Often terminal #4 is found to be loose but inspect all four as more than one terminal may be of concern). Are there one or more loose terminals?
  - **YES** — Continue to the applicable step according to the model applicability.
    - A. For RAV4, continue to step 3.
    - B. For Camry, continue to step 4.
  - **NO** — This bulletin does NOT apply. Continue diagnosis using the applicable Repair Manual.

3. Remove the outer connector cover and replace all affected terminals shown in Figure 2.
  - A. Access the electrical wiring diagram.
  - B. Refer to TIS, applicable model and model year Electrical Wiring Diagram as shown in Figure 3.
    - 2021 – 2025 RAV4:  
*EWD – General – Introduction*
    - (1) Input Division/Model/Year and click search.
    - (2) Select EWD tab.
    - (3) Click the first link:  
*General: INTRODUCTION*

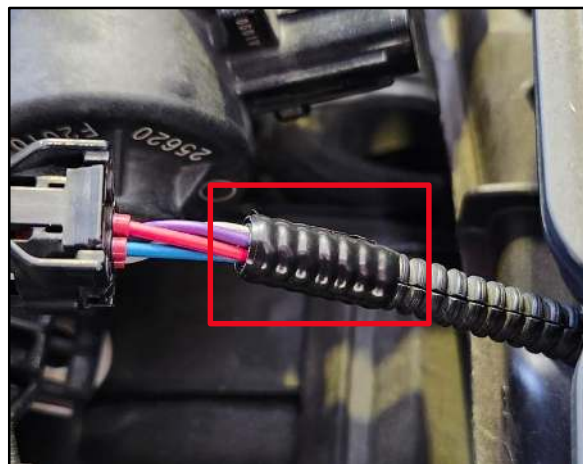
**Figure 11. Wire Wrapped in Electrical Tape**

5. Do not reinstall outer connector cover.
6. Using electrical tape, wrap the end of wire loom to secure it (see photo).
