# Service Bulletin

Bulletin No.: PIP6112

**Subject: Engine MIL On With Any DTC P0121 P0299 P1101 P00C7 Setting**

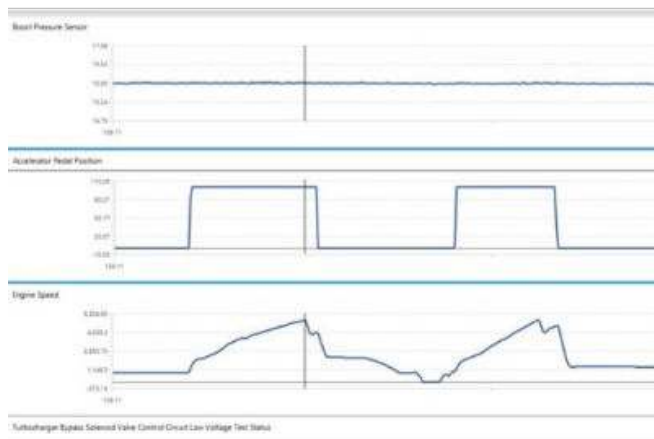
7133732

To confirm the condition, perform several W.O.T. (wide open throttle) events.

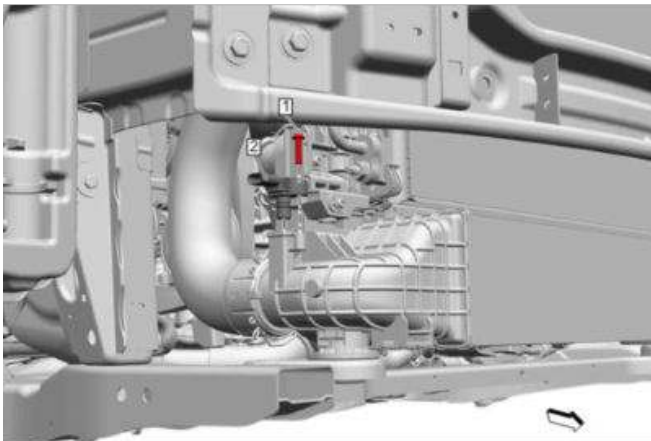
7133733

If the above testing indicates that the boost sensor is not reading correctly, follow SI for removal of the boost pressure sensor and inspect the port.

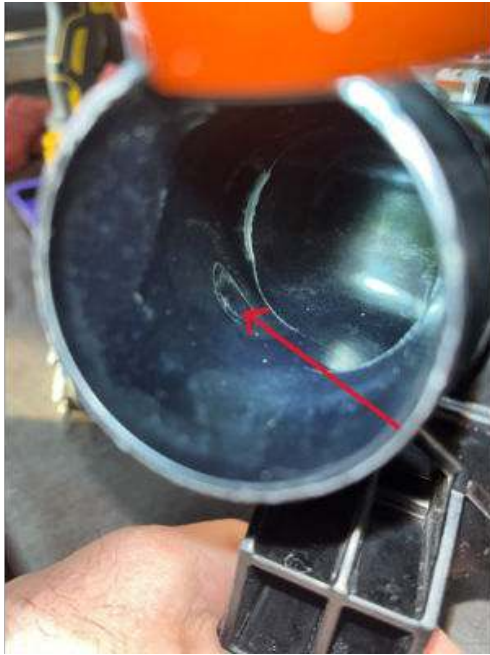
7133882

The hole in the port must extend completely through the port so the sensor can read the pressure in the CAC, see images below for example of a blocked passage.

If the hole in the port does not extend all the way through, replace the Charge Air Cooler.  
Refer to the parts catalog for the correct part application.
