## STAR ONLINE PUBLICATION

**Case Number:** S2607000004

**Symptom/Vehicle Issue:** P0480-COOLING FAN 1 CONTROL CIRCUIT (VARIABLE SPEED FAN)

**Models Affected:** 2024-2026 Chrysler Pacifica (RU)

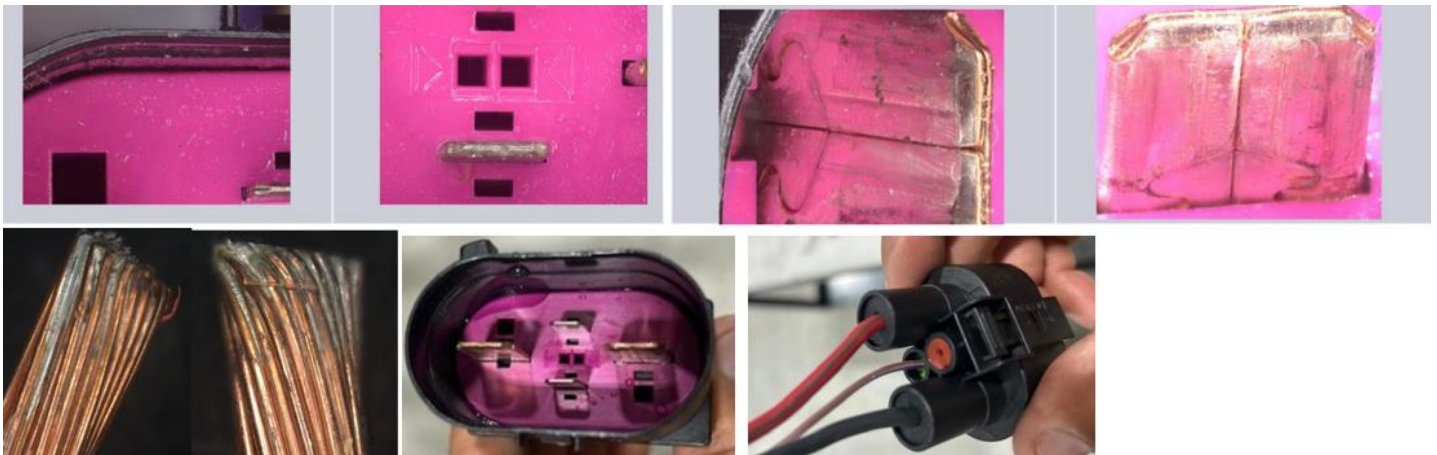
### Connector/Connection Examples Causing Faults

**Symptom/Vehicle Issue:** Water intrusion into the cooling fan motor and radiator fan connectors caused corrosion, short circuits, open circuits, and/or damaged connectors.

Contributing factors included failed weather seals, water leakage from integral harnesses, and corrosion extending into wiring, resulting in increased resistance, shorts, and fan control circuit open conditions.

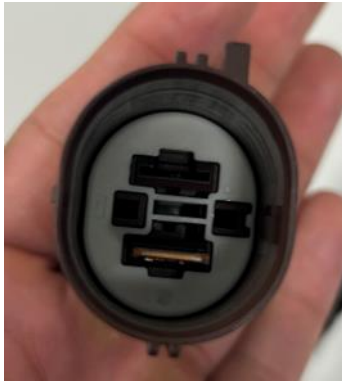
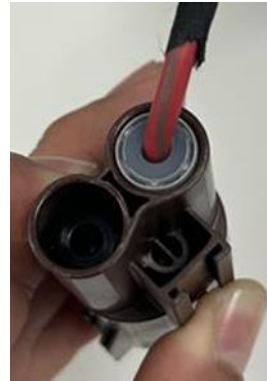
XY109A

**Discussion:** Inspect connectors the following connectors:

- Closely inspect circuits A13, K173 and Z905
- Inspect for:
  - o Proper seating
  - o Pin terminal fitment
  - o Water intrusion
  - o Terminal or wire corrosion
  - o Check for missing seals or cavity plugs on both sides of the connector.
- If any damage or contamination is found please submit a DID-I with photos.
