## Technical Service Bulletin (TSB)

### Tensioner Pad Snubber Assembly Issue

| REFERENCE: | TSB: 09-007-26<br>GROUP: 09 - Engine | Date: | May 6, 2026 | REVISION: | — |
| VEHICLES AFFECTED: | 2025 (BV) Jeep Renegade<br>This bulletin applies to vehicles built on or after August 15, 2025 (MDH 0815XX) and on or before November 15, 2025 (MDH 1115XX) equipped with the 1.5L I4 DOHC Turbo MHEV Engine (Sales Code EYP). | | | MARKET APPLICABILITY:<br><div><input type="checkbox"/> NA<input type="checkbox"/> MEA</div> <div><input type="checkbox"/> SA<input checked="" type="checkbox"/> IAP</div> <div><input checked="" type="checkbox"/> EE<input type="checkbox"/> CH</div><br>NOTE: This bulletin applies to Enlarged Europe and India & Asia Pacific markets. | |

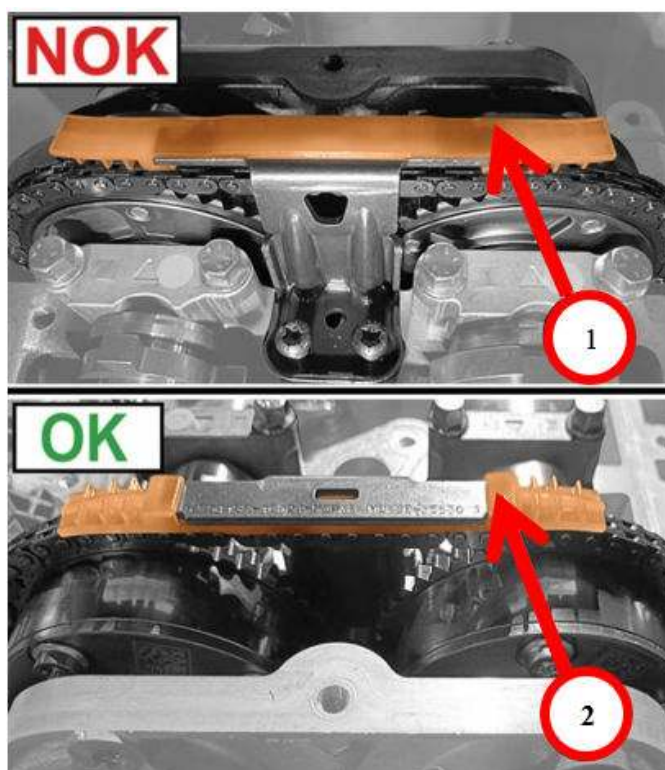
**Fig. 1**  
Snubber Conformity

| CAUSE: | Wrong assembly of the tensioner pad snubber | | | | |

2. Check conformity of the tensioner pad snubber [Fig. 1](#).

1 - Non Conforming Tensioner Pad Snubber  
2 - Conforming Tensioner Pad Snubber

3. Is the tensioner pad snubber conformed?
  - YES>>> This bulletin has been completed. Use Inspection LOP (21-10-14-91) to close the active RSU then proceed to [Step 6](#).
  - NO>>> Proceed to [Step 4](#).
4. Undo the screws and remove the cylinder head side fixed tensioner pad snubber [Fig. 2](#).

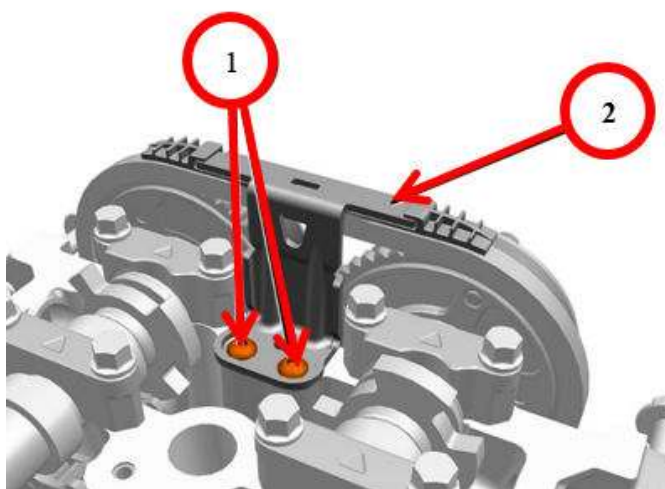
**Fig. 2**  
Remove Cylinder Head Fixed Pad

1 - Cylinder Head Fixed Tensioner Pad Snubber Screws  
2 - Cylinder Head Fixed Tensioner Pad Snubber

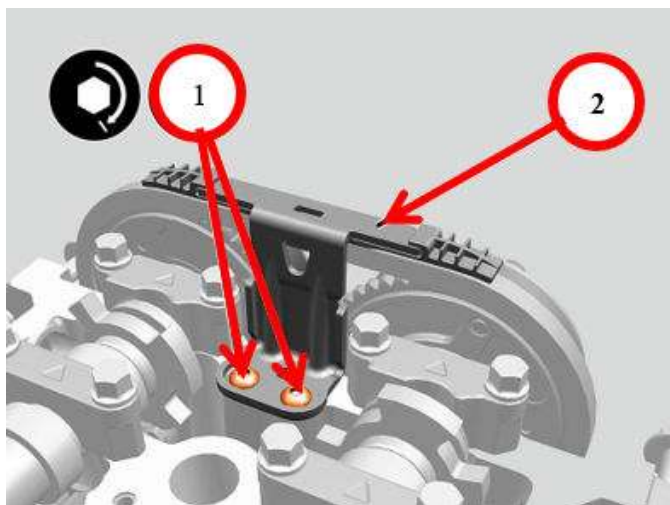
**Fig. 3**  
Install Cylinder Head Fixed Pad

1 - Cylinder Head Fixed Tensioner Pad Snubber Screws  
2 - Cylinder Head Fixed Tensioner Pad Snubber

5. Put the **NEW** cylinder head side fixed tensioner pad snubber in place and tighten the fixing screws to  $0.9 \pm 0.1$  daNm ( $90 \pm 0.1$  cN) [Fig. 3](#).
