## STAR ONLINE PUBLICATION

**Case Number:** S2608000006 Rev. B

**Models Affected:** 2026 Jeep Cherokee (KM)

**Symptom/Vehicle Issue:** Limp Home Mode, Red Wrench Lamp Illuminated. DTCs P0C01-00 - Drive Motor A Current High And/Or P0C04-00 - Drive Motor B Current High

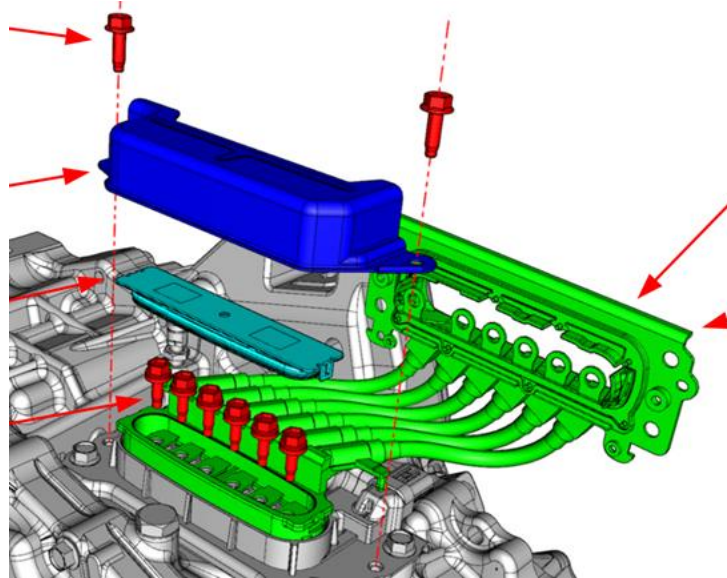
2. Remove the Transmission cable interface cover (Blue) and bolts securing the cables.

Inspect the Transmission connections for signs of cross-threading, damage, loose connections, and metallic debris.

**Caution:** Different length bolts for Trans and DMPI, ensure bolts are in the right position.

**Transmission bolts Part Number: 06514797AA**

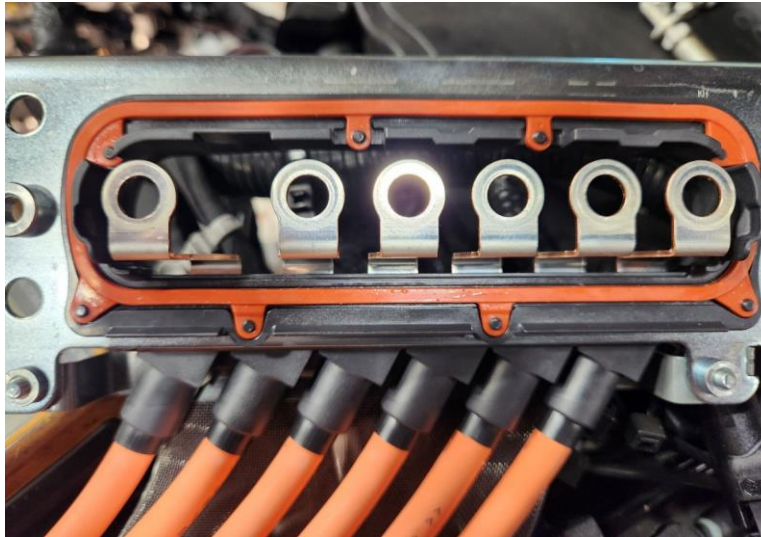
(3)

### Wire Harnesses
