# Service Bulletin

Bulletin No.: PIP5927E

**Subject: Diagnostic Tips: Possible DTC P0237 P0101 P1101 P0234 or P0299 Reduced Engine Power**

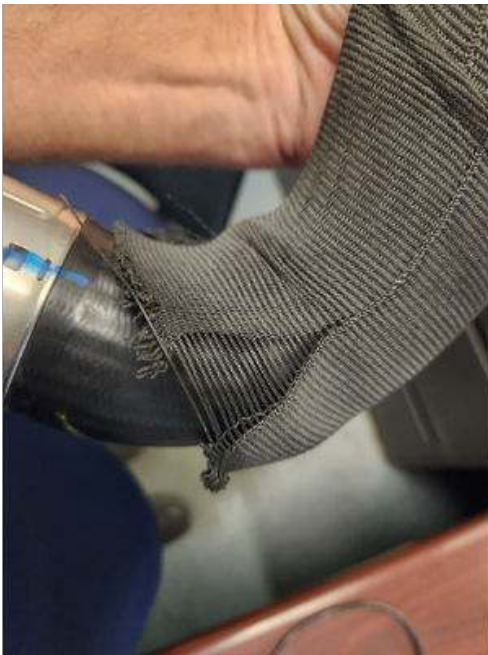
#1

Inspect the Charge Air Inlet Pipe at the Turbocharger to see if the anti-abrasion sleeve shows signs of being shredded or split.

Pictures below show damage to abrasion sleeve on Charge Air Inlet Hose.

Replace Charge Air Inlet Pipe assembly using latest parts listed in EPC.

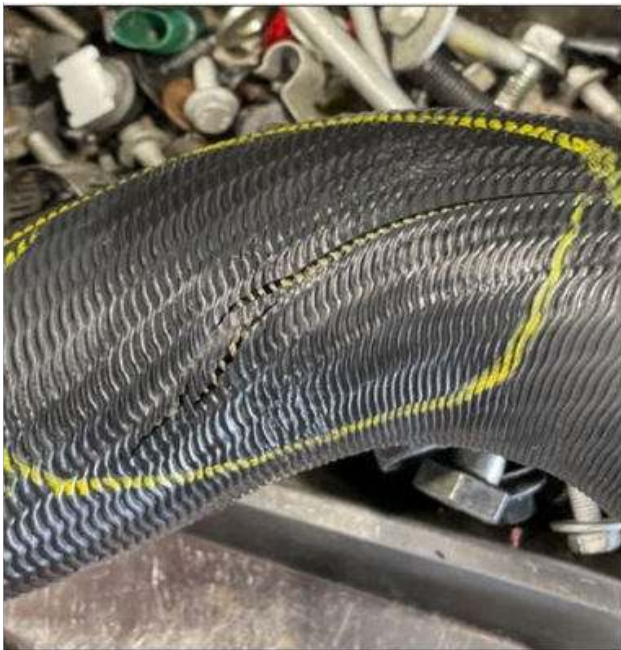
If this type of damage has been identified remove the Charge Air Inlet Hose assembly and inspect the Charge Air hose beneath the abrasion sleeve for signs of being split.

This type of damage would allow the hose to swell under pressure damaging the abrasion sleeve and altering the readings within the boost control system or create a potential air leak.

#3 Picture below inside the circled area shows damage to inner hose beneath abrasion sleeve
