# Service Bulletin

Bulletin No.: PIP6113

**Subject: Diagnostic Tip - Intermittent MIL / Engine Stalls At A Stop / DTC P0191 And Occasionally P0172**

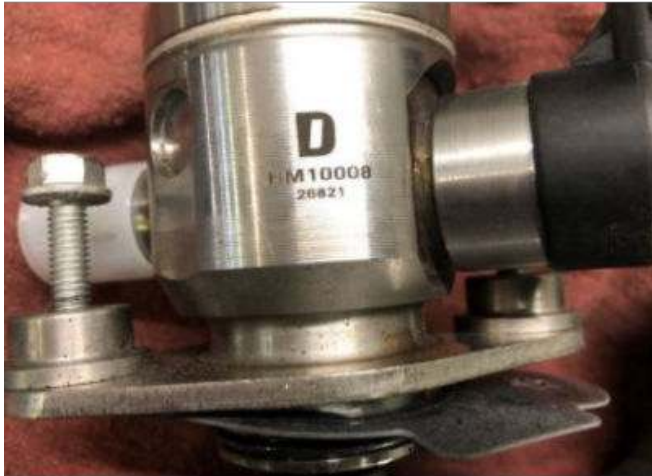
7135561

Below are some examples of non original manufacture / non GM high pressure fuel pump markings on the high pressure fuel pump body.

If the high pressure fuel pump is not an original manufacture / GM part, install one and evaluate the vehicle.
