# TECHNICAL SERVICE BULLETIN

EC26-013

## ENGINE NO START WITH KEY SYSTEM ERROR AND DTC B2C20-24 STORED IN THE BCM

2026 QX60 (L51)

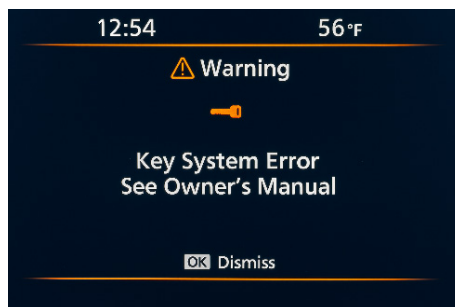
Figure 1

The customer states the engine will not start and "Key System Error" warning is displaying in the Information Display (Combination Meter) (Figure 1),

DTC B2C20-24 for "STARTER CONTROL RELAY" is stored in the BCM.

**HINT:** This DTC and warning message (Figure 1) may occur if the customer does not place the vehicle in Park Gear according to the Owner's Manual for shifter operation.

1. Confirm the current ECM part number.
2. Confirm the current TCM part number.
3. Reprogram the ECM, and then the TCM, if applicable.
4. Erase the DTCs.
