# Service Alert

INFOTAINMENT CENTER DISPLAY AND CONNECTED VEHICLE  
IMPROPER OPERATION

Service Alert No.: SA-015/26

2026 CX-5

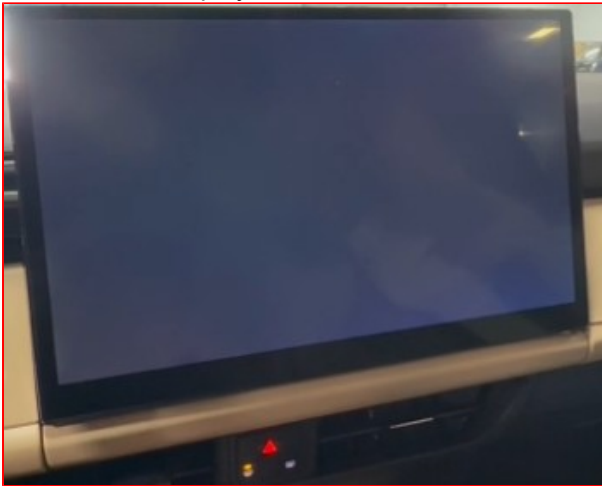
4. The center display screen is blank.

- This condition is related to Item 1 above. Refer to TSB 16□004/26. **Did the TSB repair the customer's concern?**
  - **YES:** The TSB resolved the concern — repair complete.
  - **NO:** Proceed with standard MGSS troubleshooting.

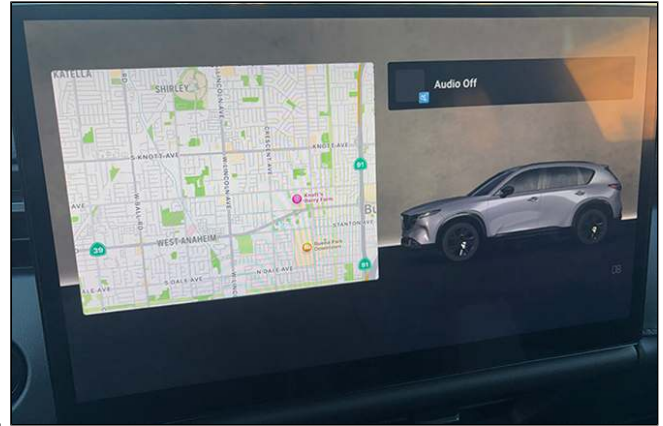
8. Infotainment Center Display Home Screen Partial Boot Up.

- Top icons are not displayed.
- Bottom climate controls are not displayed.
- Google Voice is inoperative.

Confirm that the Cockpit Domain Controller (CDC) is updated to the latest software version.

Navigate to MGSS → Mazda Connect/Connected Vehicle → MAZDA CONNECT Updates → MAZDA CONNECT 3.

- Software update is available: Update the software, then confirm the repair.
- Software update is not available: Proceed with standard MGSS troubleshooting.
