**Error Message "Engine Power Reduced", Fault Memory Entry "Exhaust Flap Actuator" (P047600 / P04A000) in DME Control Unit (32/26)**

Vehicle Type: **911 GTS (992)**  
**911 4 GTS (992)**  
**911 Turbo S (992)**

Model Year: **As of 2025 up to 2026**

Concerns: **Exhaust flap actuator**

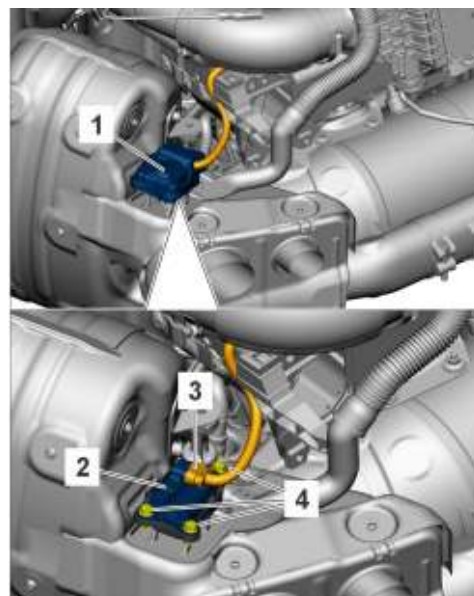
*Exhaust flap actuator (shown as "installed")*

- 6 Fit the electric plug connection ⇒ *Exhaust flap actuator (shown as "installed") -3-* to the **removed** exhaust flap actuator ⇒ *Exhaust flap actuator (shown as "installed") -2-* until it locks perceptibly.
- 7 Repeat drive link test on the affected exhaust flap actuator.

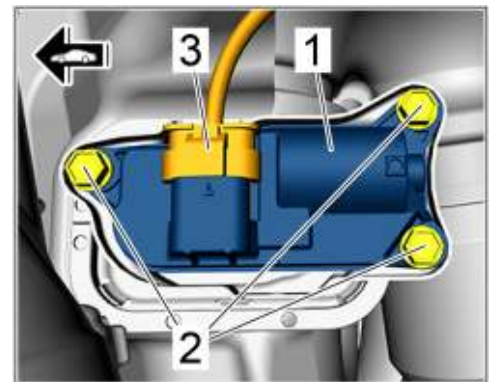
- 6 Remove affected exhaust flap actuator.  
⇒ Workshop Manual '265119 Removing and installing exhaust flap actuators'
- 7 Fit the electric plug connection ⇒ Exhaust flap actuator (shown as "installed") -3- to the **removed** exhaust flap actuator ⇒ Exhaust flap actuator (shown as "installed") -1- until it locks perceptibly.
- 8 Repeat drive link test on the affected exhaust flap actuator.
