## Technical product information

| Topic | EPB Warning light in DIP - Front door/s power latch system intermittent - DTC U112300 within Address 03 and Address 46 |
| Brand | Bentley |
| Transaction No. | 2075034/4 |

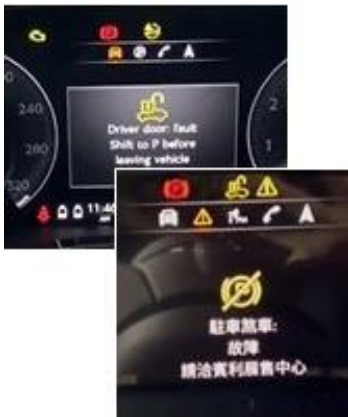
Figure 1

One or a combination of the following is evident within the DIP (Figure 1)

- Electronic parking brake warning

- Drivers door power latch intermittent operation warning

- The front door/s power latching system sporadically does not work. The door remains in the first latch of the door lock but is not closed by the power latching system
- DTC U112300: Databus error value received Symptom 450560 evident within the ESP control unit (electronic stabilisation program) (J104)

DTC U112300 symptom code 65759 evident within the Onboard supply control unit 2 (J393)

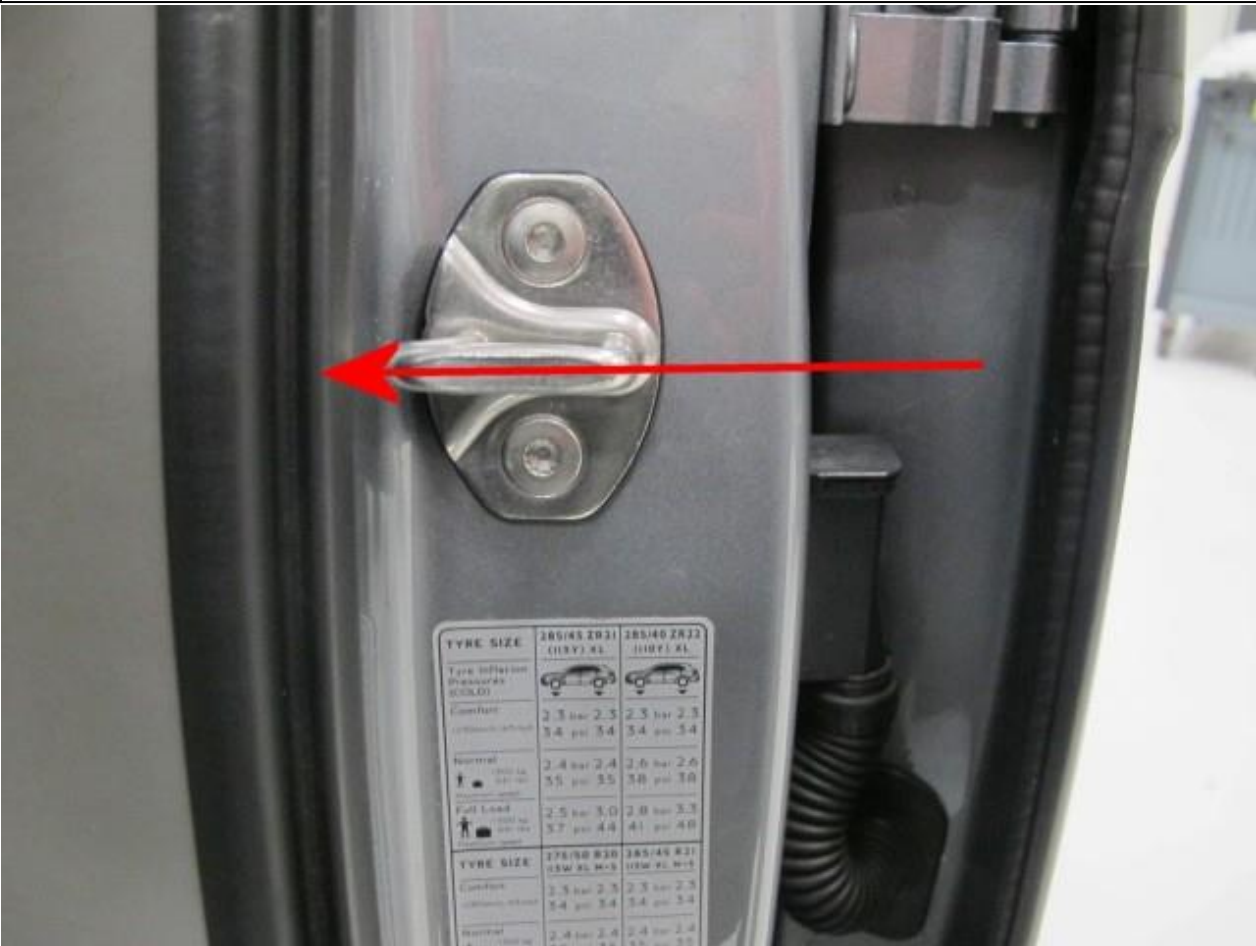
Figure 2

The micro switch signal of the door lock is not recognised or is recognised briefly, a counter press of the door by the operative is required to clearly recognise the signal

Insufficient back pressure of door (door closing loads / seal load) results in the pawl microswitch signal becoming too short. This short signal is then calculated as an error state by address 0003 -Brake electronics

1) Confirm the striker runs into the centre of the rotary latch of the door lock and adjust as necessary - Refer to Rep.Gr 57 - Door striker - To remove and fit

In addition, adjust the striker as far as possible (at least 0.5 mm) further inwards (Figure 2)
