## TECHNICAL SERVICE BULLETIN

### Engine Misfire With An Illuminated MIL And DTC(s) P0301, P0302, P0303, And/Or P0304 Stored In The PCM

**26-2210**

26 May 2026

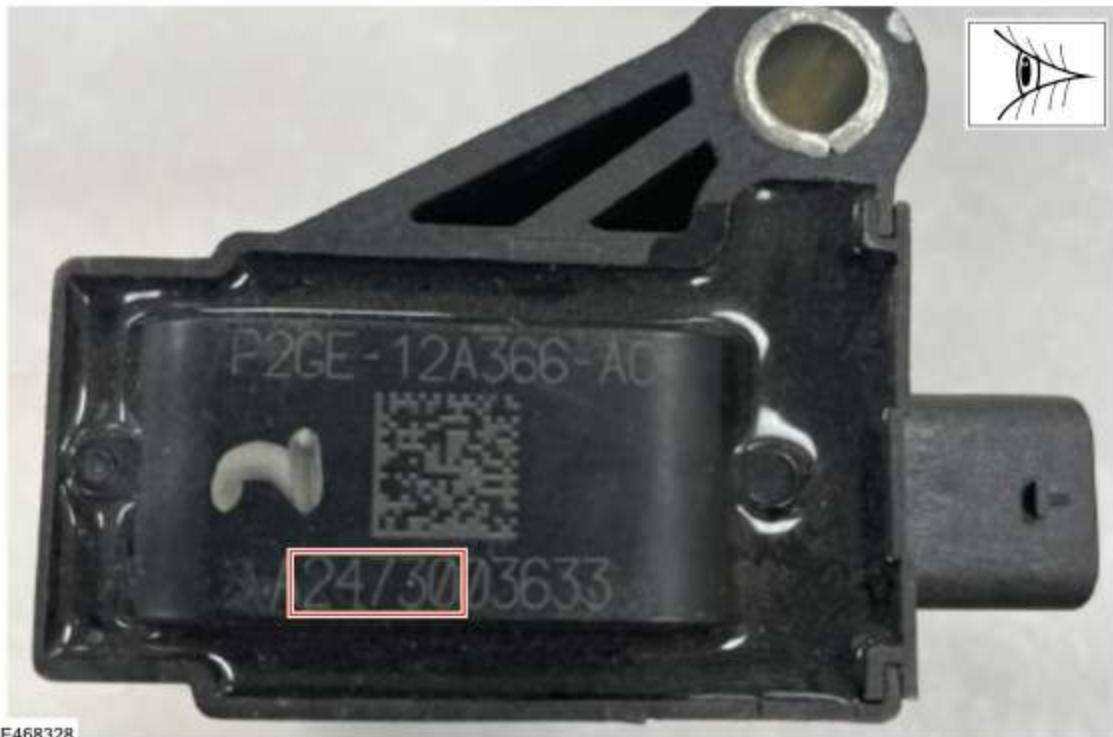
**NOTE:** Each ignition coil has an 11-character alphanumeric manufacture code printed on top. The second through sixth characters of the manufacture code are the date code (Figure 1). The date code can be interpreted using the chart below.

**NOTE:** The date code in Figure 1 is 24730 = 30-Jul-2024

1. Access the ignition coil for the cylinder setting the misfire DTC. Refer to the WSM, Section 303-07 > Removal and Installation > Ignition Coil-On-Plug. Perform only the steps necessary to view the date code located on the top of the suspect ignition coil.
2. Inspect the date code on the ignition coil for the cylinder setting the misfire DTC. Is the ignition coil build date on 01-Apr-2024 and through 31-Oct-2024?
  - (1). Yes - install a new ignition coil on the suspect cylinder. Refer to the WSM, Section 303-07 > Removal and Installation > Ignition Coil-On-Plug.
  - (2). No - this article does not apply. Continue with normal diagnostics outside of this article. Refer to the WSM, Section 303-07.
