| Topic | Window Drop Glass Operation Continental GT/GTC 19-24MY |
| Transaction No. | 2080375/2 |

Window Drop Glass Operation | Continental GT/GTC |19-24MY

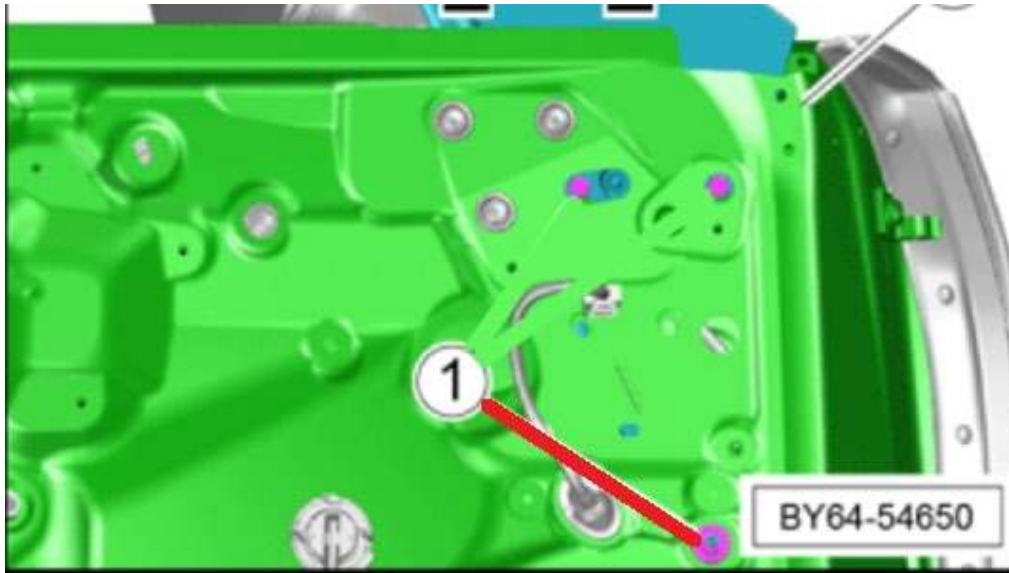
*Figure 1. Image for reference, glass does not require removal from vehicle*

In instances of multiple window drop concerns it has been found that to achieve the glass set specification, some adjusters are being adjusted out of specification.

In some cases, since not all adjusters are visible, there is a possibility that the adjusters can be set to their maximum inboard/outboard and induce excess tension in the regulators and affect the angle the windows enter the seals. There is free play built into the front and rear regulators, therefore as the windows are being held in place by the cant rail/convertible roof seals when closed, this may not be apparent when measuring. However, these extreme adjustments can cause issues with how the windows enter the cant rail/convertible roof seals or how the front and rear glasses interlock with each other, in some cases this can cause the seals to pinch and cause an anti-trap condition leading to window reversal.

The measurement between the bottom of the mounting washer and division bar frame, is 12.5mm.

1. loosen the lock nut.
2. Screw the adjuster fully clockwise until it bottoms out on the frame.
3. Unscrew the adjuster counterclockwise by four complete turns.
4. Resecure the lock nut.
